## Inspection Report

**Client Name** : QINGDAO HENGER SHIPPING SUPPLIES CO., LTD.

**Declared Commodity & Quantity** : Ship Launching Airbag  
D2.0 X L18M: TOTAL: 16PCS  
D2.0 X L15M: TOTAL: 6PCS  
D2.0 X L6M: TOTAL: 2PCS

**Inspection date** : June 9,2022

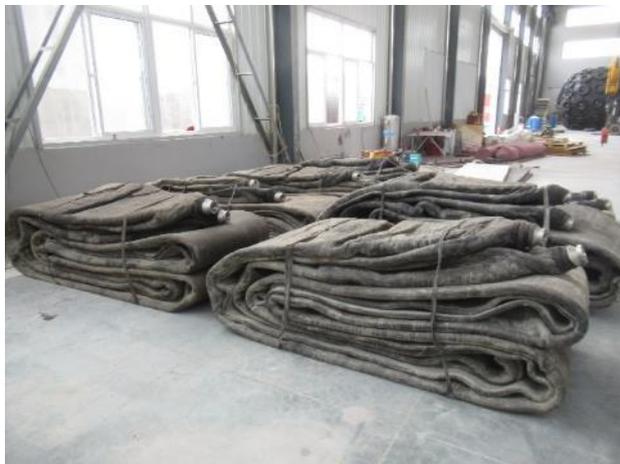
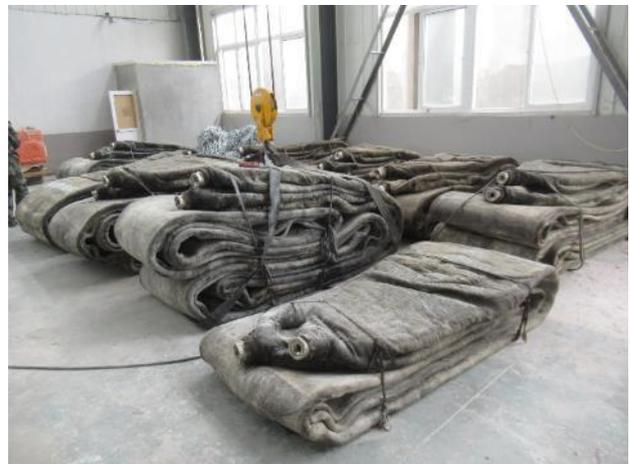
#### Storage condition

At the time of our attendance at the factory, we found the ship launching airbags were stored in the manufacturer's warehouse in normal condition.

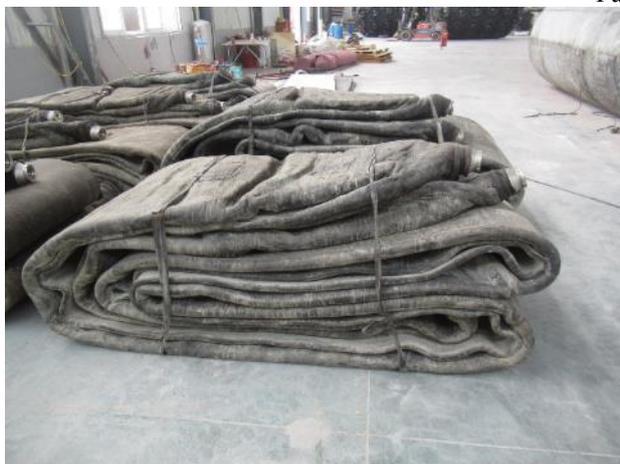
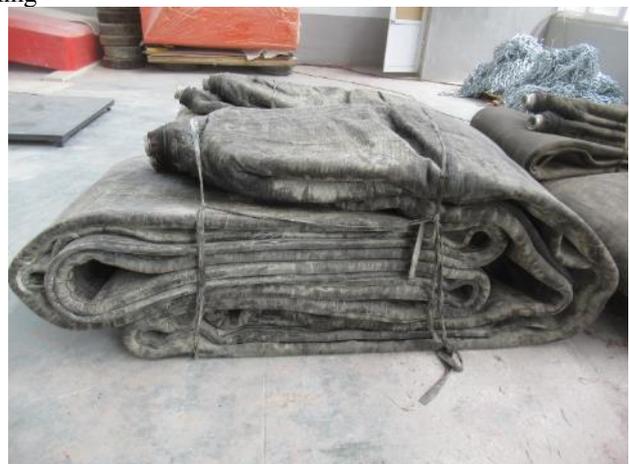
#### Packing

The ship launching airbags were folded and tied by ropes.

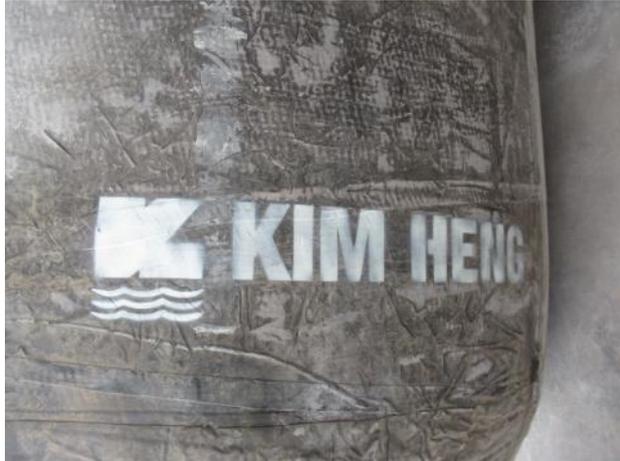
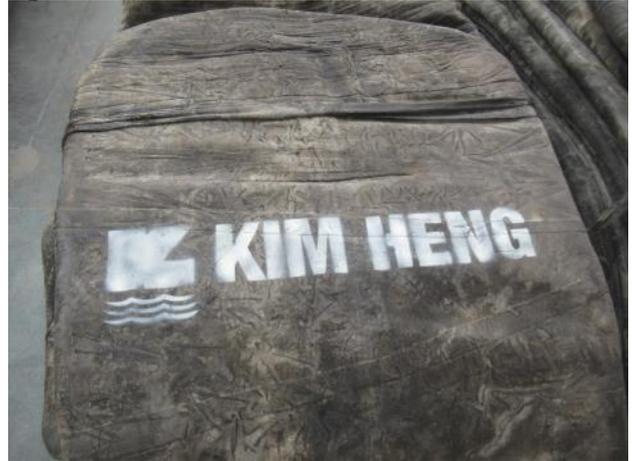
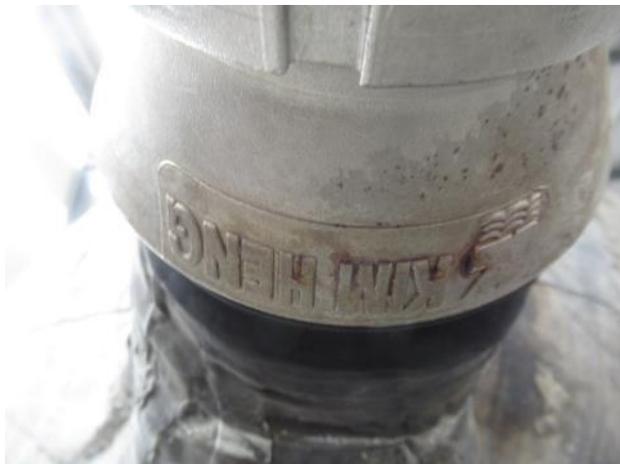
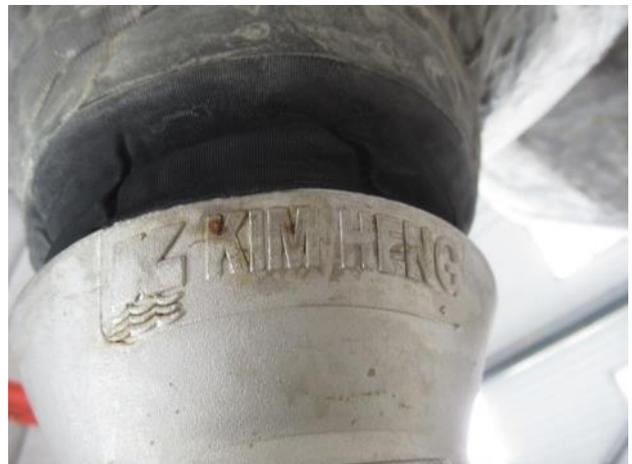
Marking

The marking "KIM HENG" was painted on the surface of the ship launching airbags, and rivetted on the inflating valve, details as attached photos.

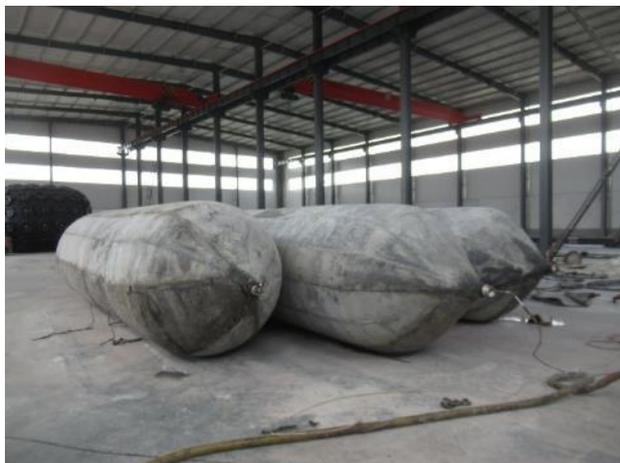
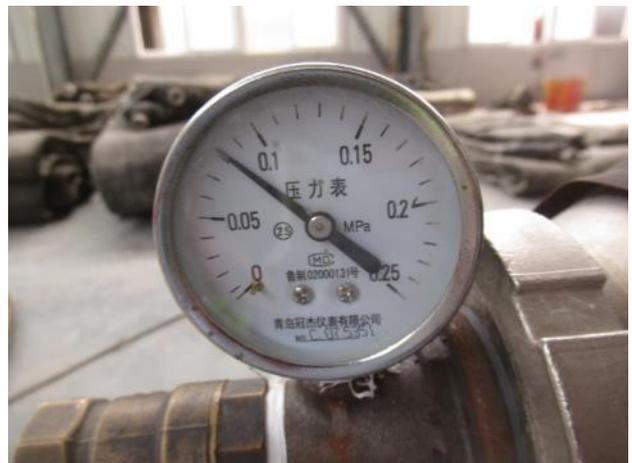
Airtightness testing to check for leakage

According to client's requirement, the above mentioned 3pcs of ship launching airbag were randomly selected, charged at airtightness and pressure declared by 0.08Mpa under BV inspector witness. After 1 hour, checked the pressure again, as far as visually checked, it's found in normal conditions, no air leak was found visually.

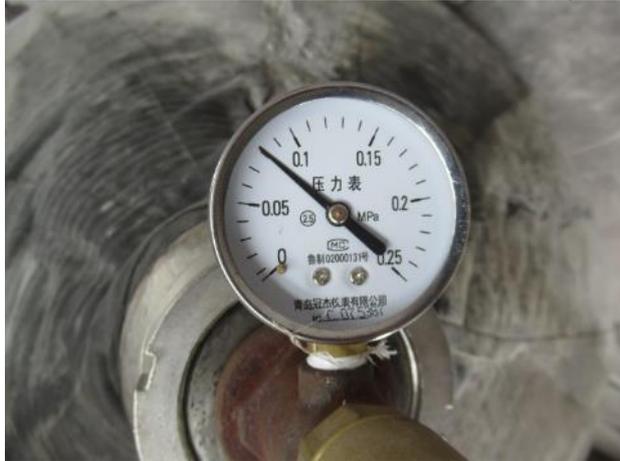
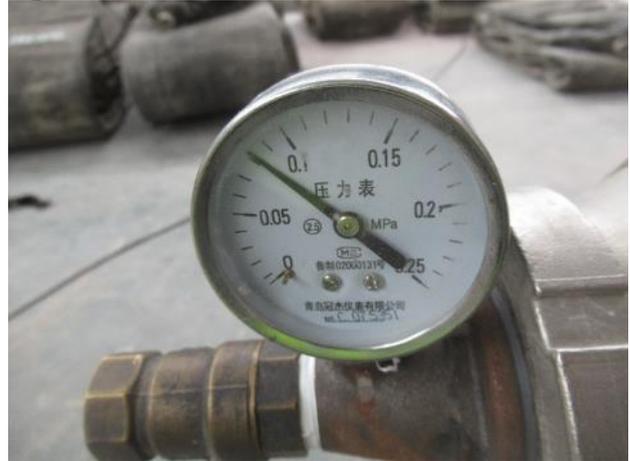
checked the pressure again after 1 hour

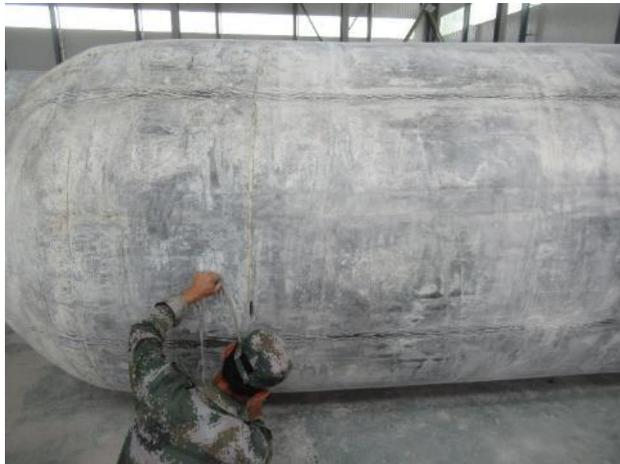
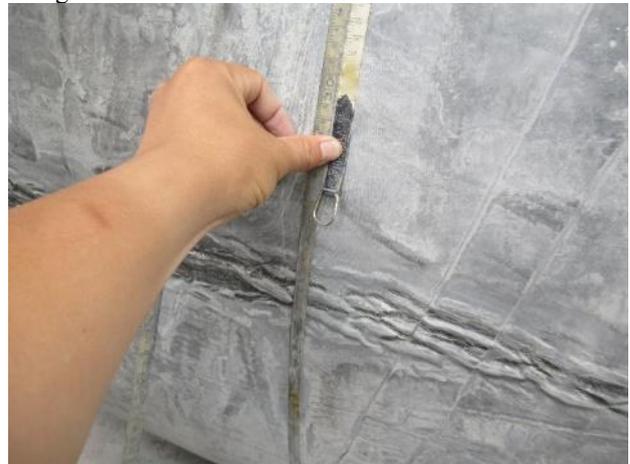
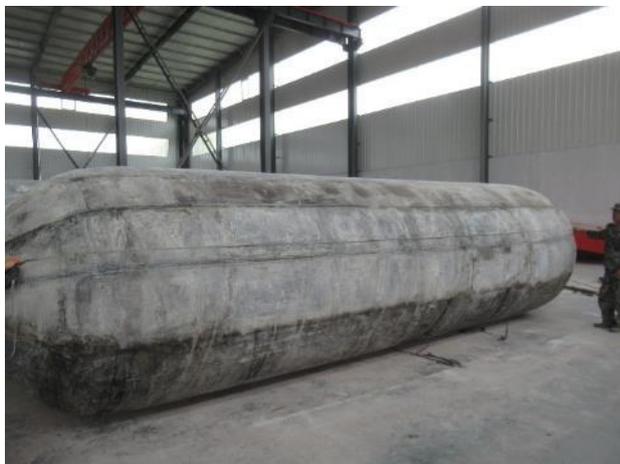
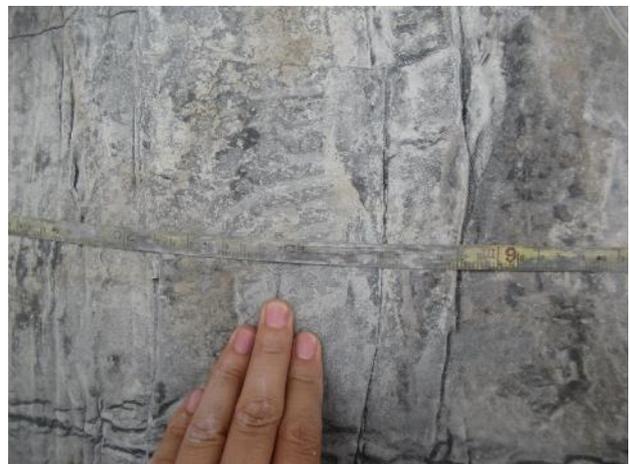
Size checking

Size	Diameter(M)	Effective Length(M)
D2.0 X L18M	2.00	18.05
D2.0 X L15M	2.01	15.15
D2.0 X L6M	2.01	6.10

The measurement tool was provided by the factory without the calibration certification, and the measurement was done approximately as shown in pictures hereunder. The result was for reference only.

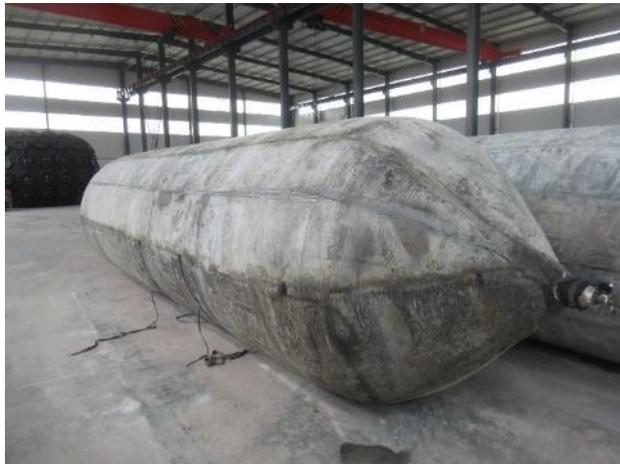
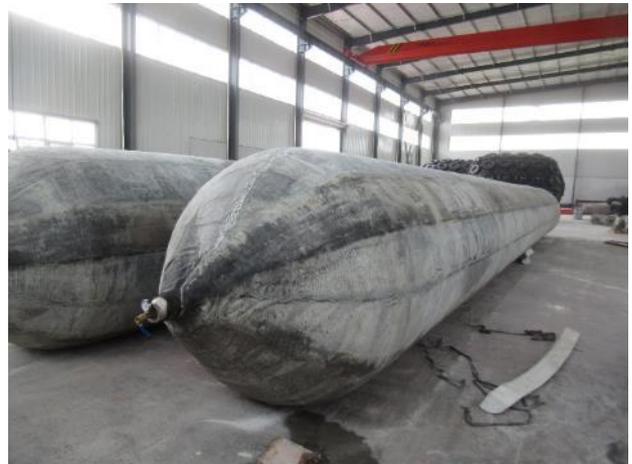
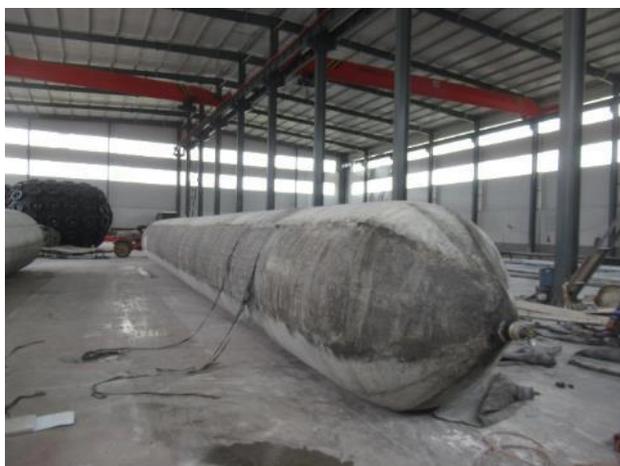
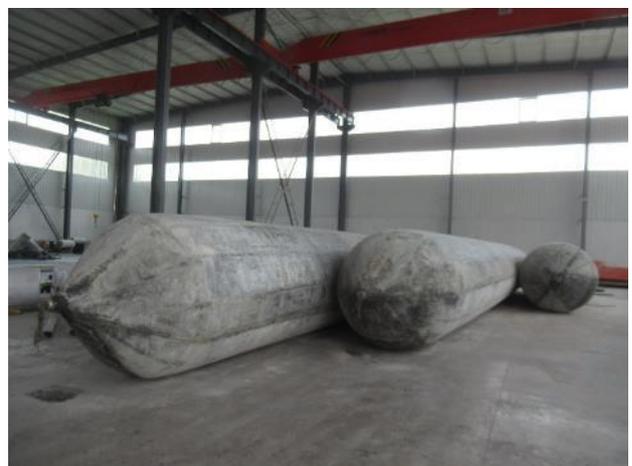
Overall visual inspection

According to client's requirement, the above mentioned 3pcs of ship launching airbags checked by visually, BV inspector found the airbags in normal condition without obviously damages and scratches.
