Inspection Report

- Applicant** : Qingdao Henger Shipping Supplies Co., Ltd.
- Declared Commodity & Quantity** : Pneumatic rubber fender
DIAMETER:2.0M, LENGTH:4.0M: 5PCS
DIAMETER:1.5M, LENGTH:3.0M: 4PCS
DIAMETER:1.0M, LENGTH:3.0M: 2PCS
DIAMETER:1.0M, LENGTH:2.0M: 3PCS
- Inspection Date** : December 26, 2023
- Inspection Location** : Jimo, Qingdao City, Shandong Province, China
- Scope of Inspection** : 1. Packing and Marking
2. Size checking (the overall L & D)
3. Overall visual inspection
4. Air tightness test to check for leakage

BV Ref.: GTS_2023_370416

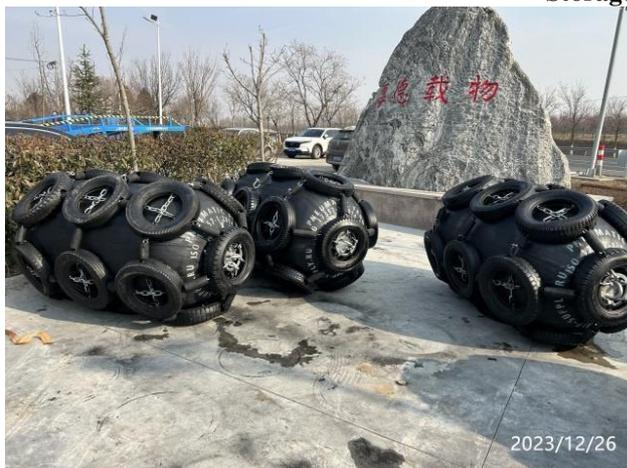
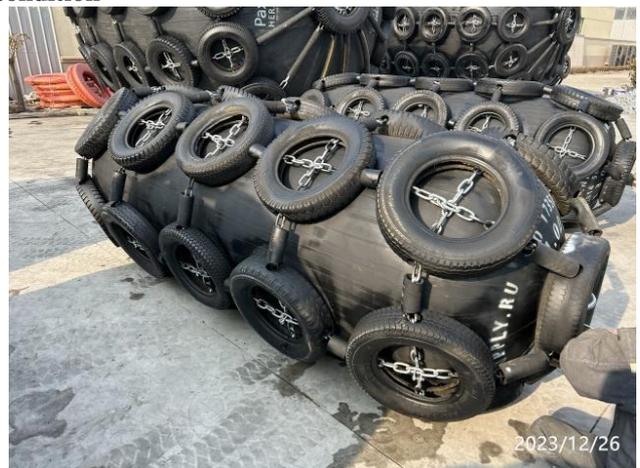
**Photo Report
Storage condition**

At the time of our attendance at the factory, we found the fenders were stored in the manufacturer's open yard, in normal condition.

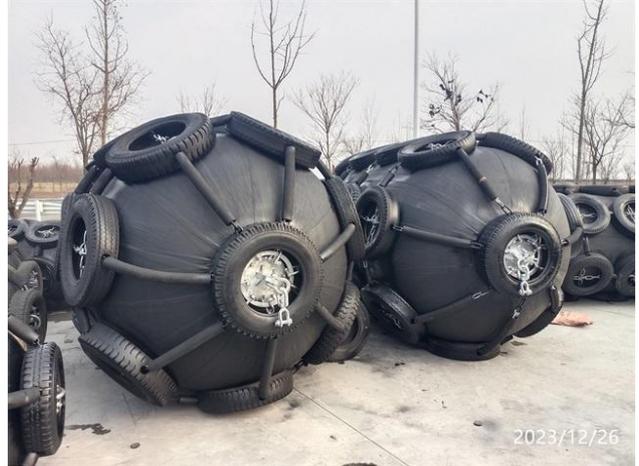
The Fenders were in nude packing, with the chains and used tires around the fenders' body.

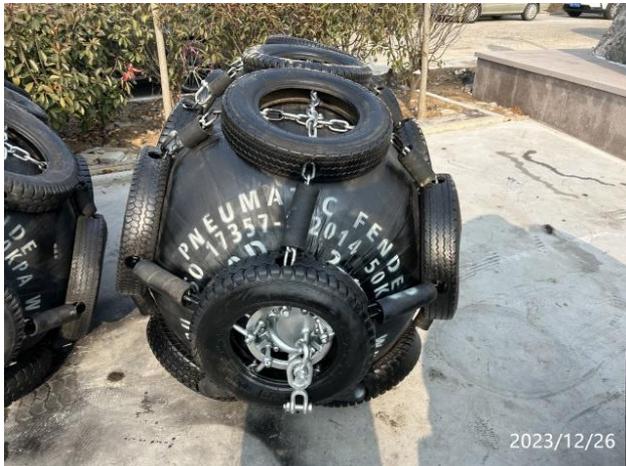
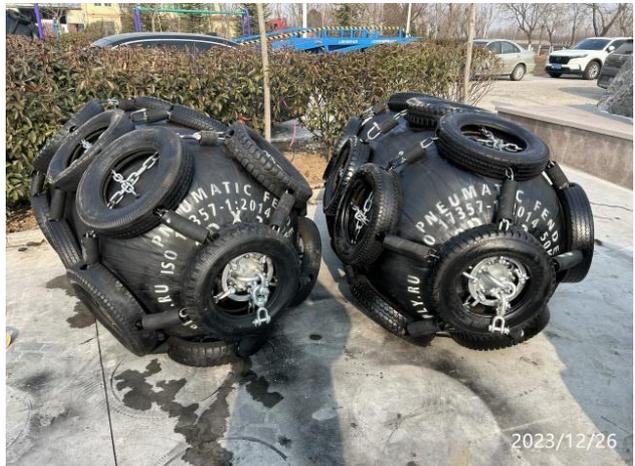
Size: 1.0D X 2.0L

The marking was printed on one end of fenders, details as below:

PNEUMATIC FENDER
ISO 17357-1:2014 50KPA
1.0D X 2.0L (1.0D X 3.0L or 1.5D X 3.0L or 2.0D X 4.0L)
WWW.SHIP-SUPPLY.RU

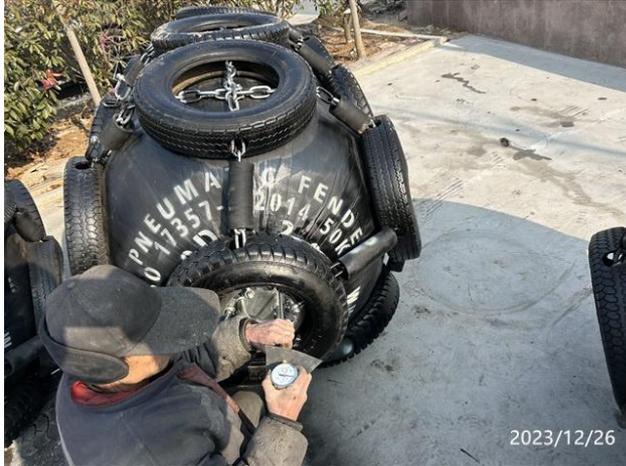
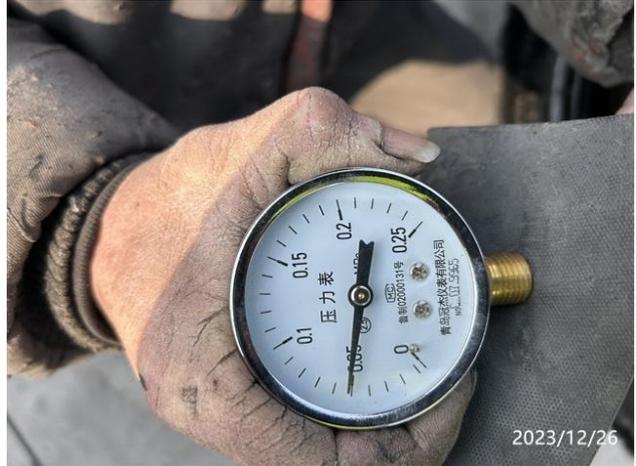
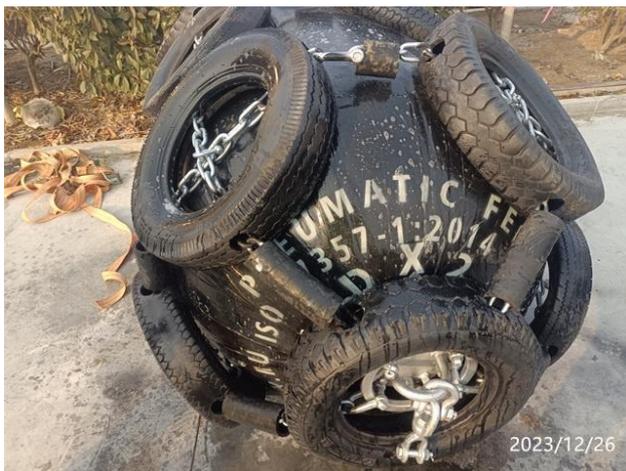
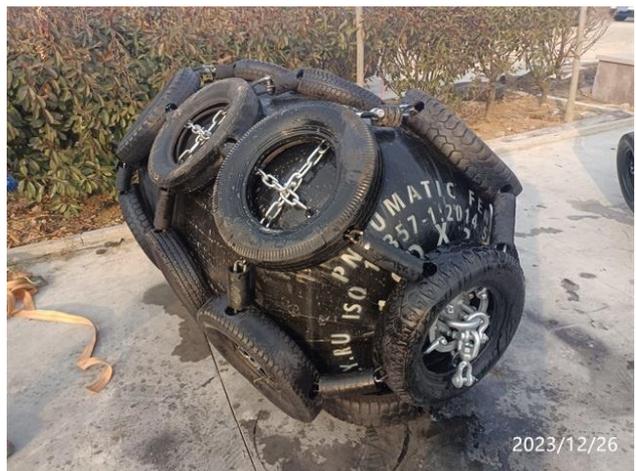
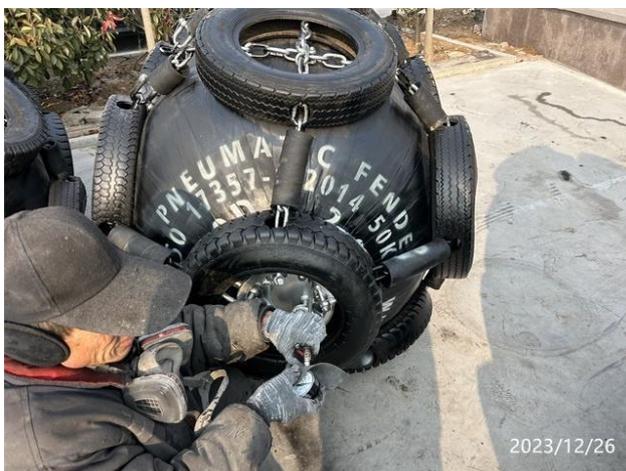
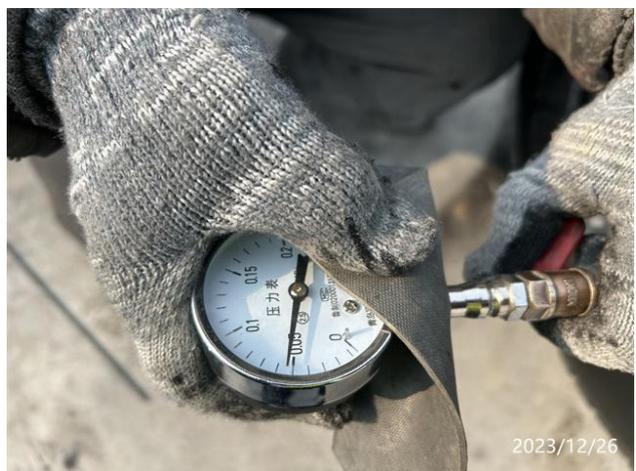
Size: 1.0D X 2.0L

According to client's requirement, the above mentioned 8 pieces of fenders were charged at pressure declared by 50KPa under BV inspector witness, then covered with the soap water on the surface of the fender to check the air leak if any, as far as visually checked, it's found in normal conditions, after 1 hour, checked the pressure again, no obviously air leak was found visually.

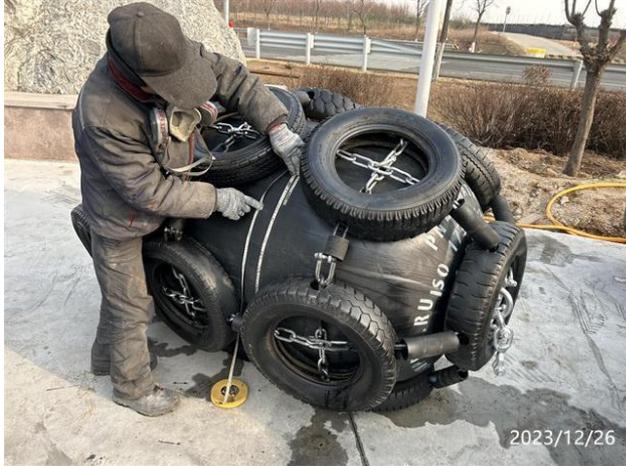
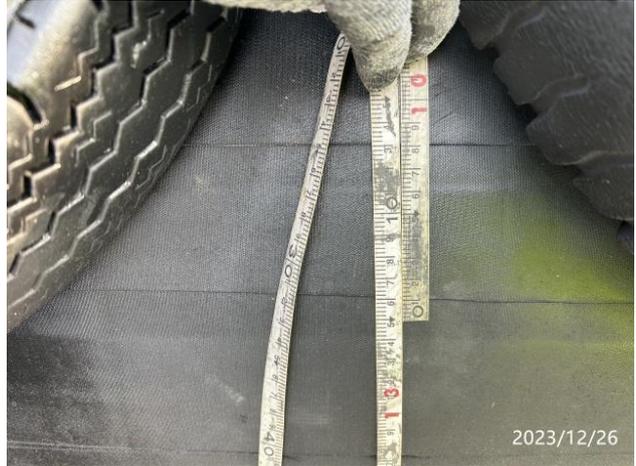
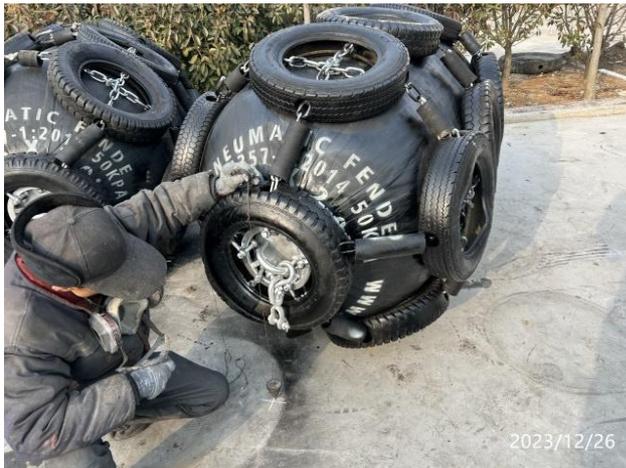
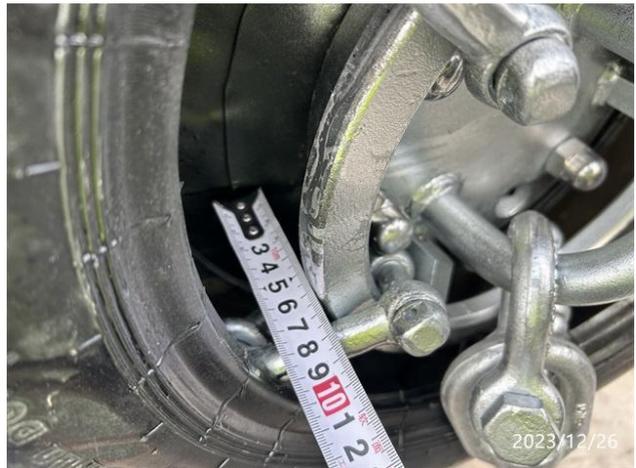
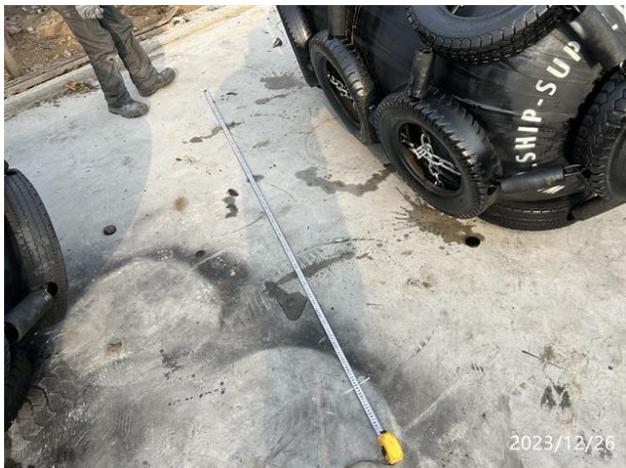
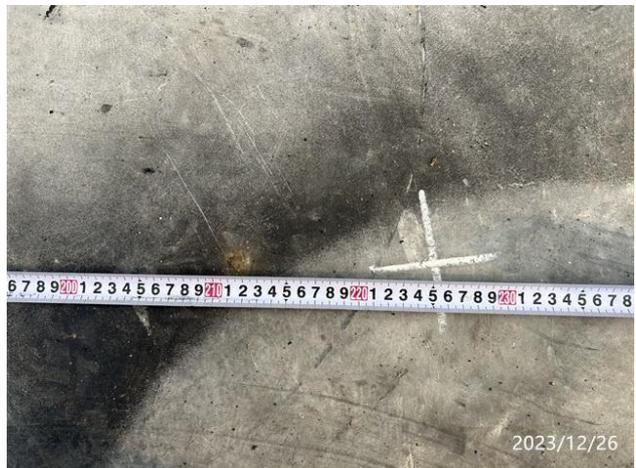
Size checking
Size: 1.0D X 2.0L

Size: 1.0D X 2.0L		
Sample No.	Diameter(M)	Length(M)
1	1.00	2.01
2	1.01	2.00
Size: 1.0D X 3.0L		
1	1.00	3.05
2	1.00	3.08
Size: 1.5D X 3.0L

The measurement tools were provided by the factory without the calibration certificate, and the measurement was done approximately as shown in pictures hereunder. The result was for reference only.

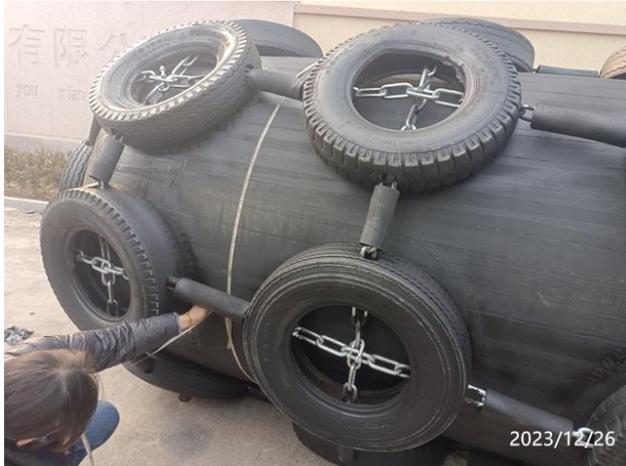
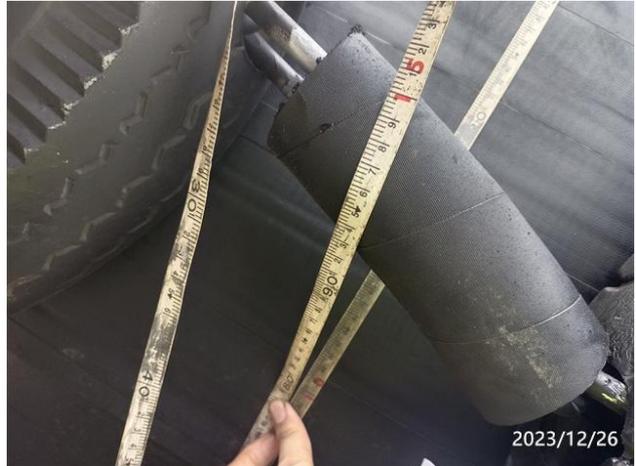
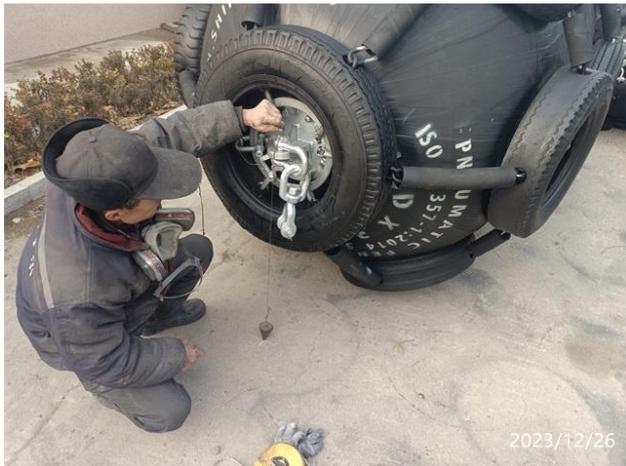
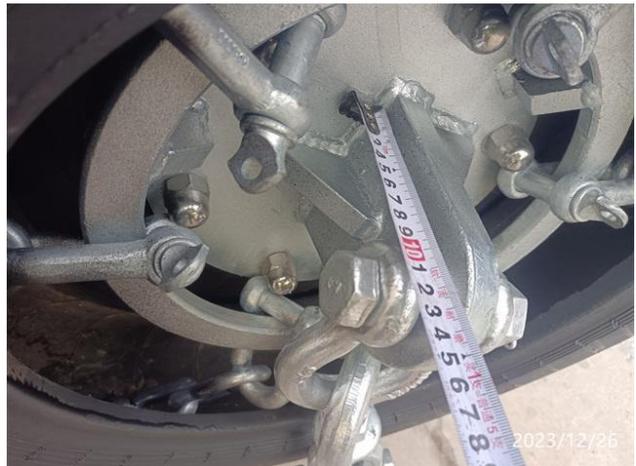
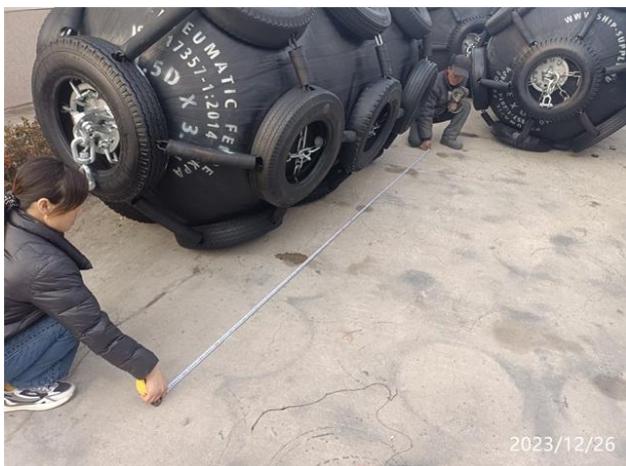
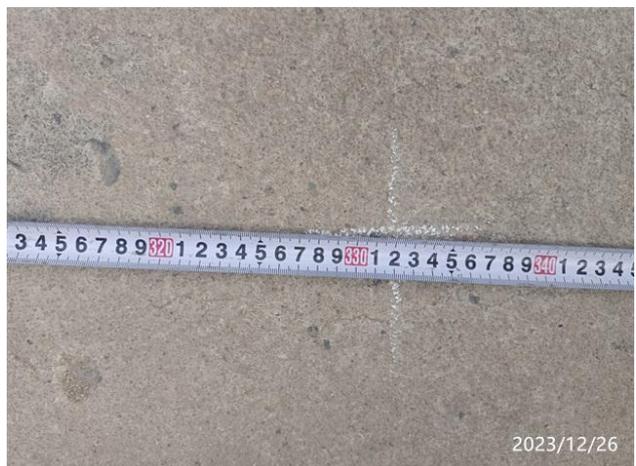
Size: 1.5D X 3.0L

1	1.52	3.07
2	1.52	3.09
Size: 2.0D X 4.0L		
1	1.99	4.05
2	2.00	4.02

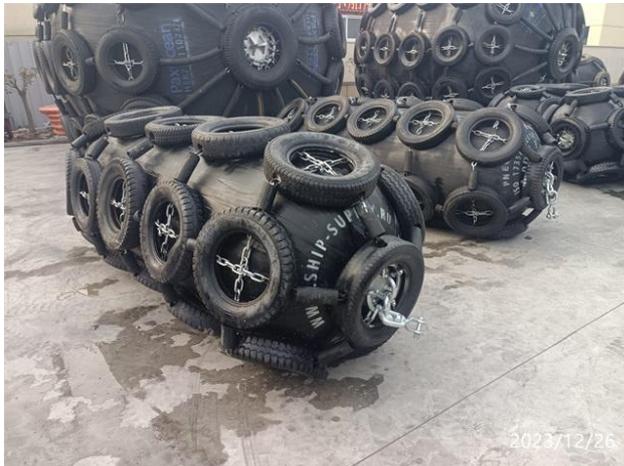
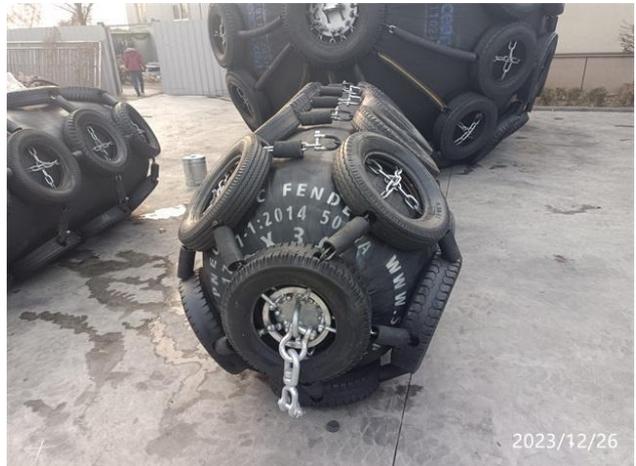
Size: 1.0D X 3.0L

According to client's requirement, BV inspector found the above mentioned 14 pieces of fenders were in normal condition without obviously damage and scratches.
