BV Ref.: GTS_2023_330472

Inspection Report

Applicant : Qingdao Henger Shipping Supplies Co., Ltd.

Declared Commodity & Quantity : Pneumatic rubber fender
DIAMETER:1.2M, LENGTH:2.0M: 5PCS

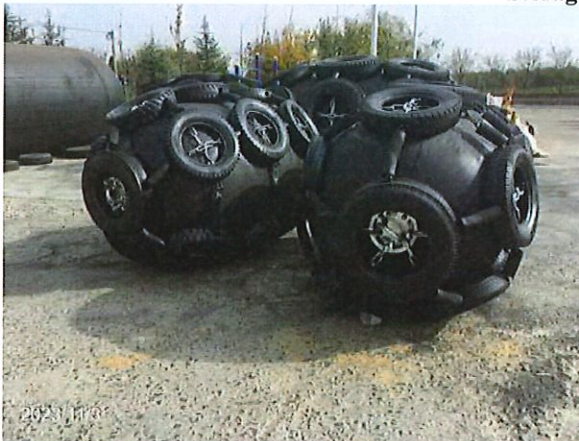
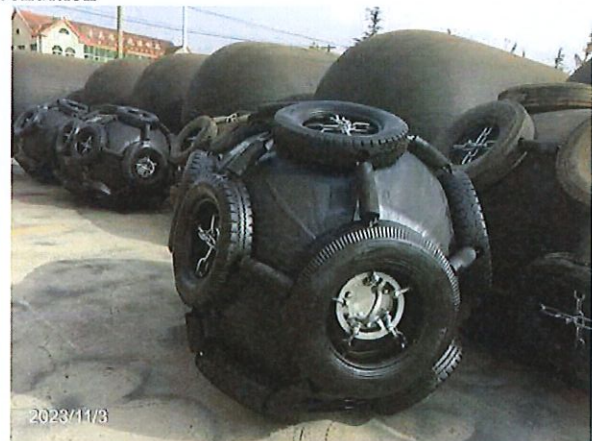
**Photo Report
Storage condition**

At the time of our attendance at the factory, we found the fenders were placed in the manufacturer's open yard, in normal condition.

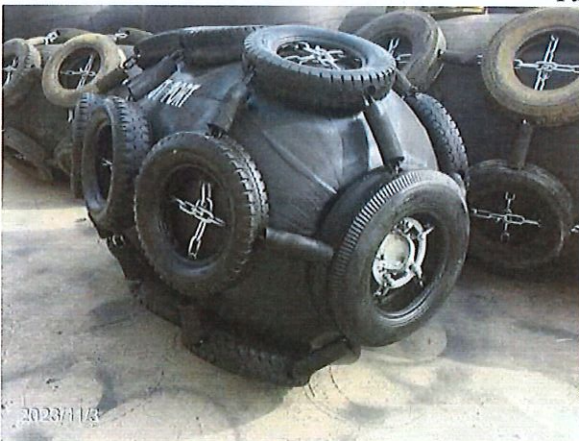
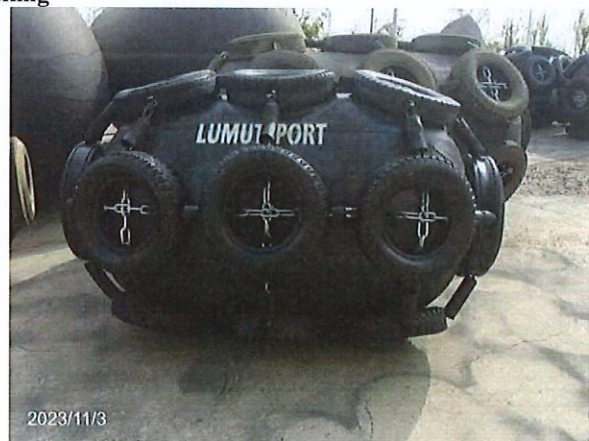
Packing

The Fenders were in nude packing, with the chains and used tires around the fenders' body.

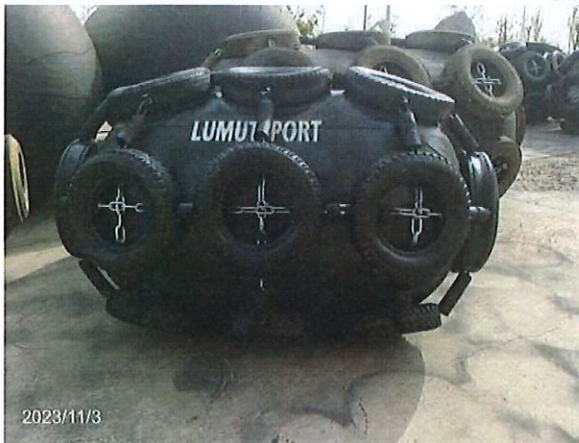
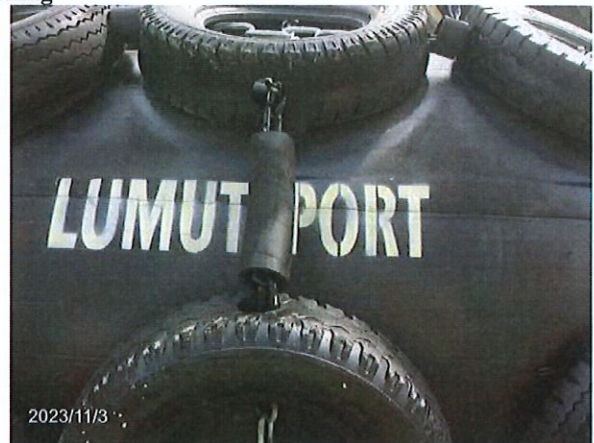
Marking

The marking was printed on the body of fenders, details as below:

LUMUT PORT

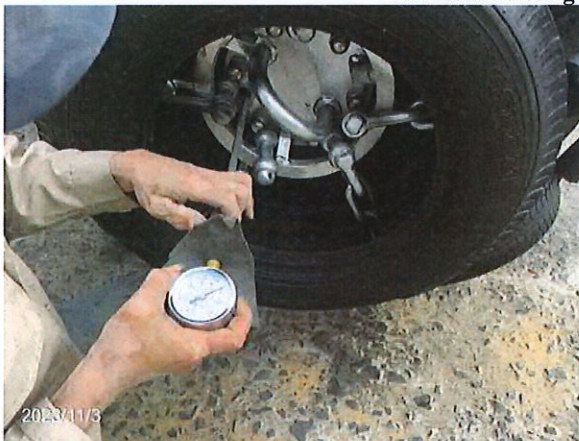
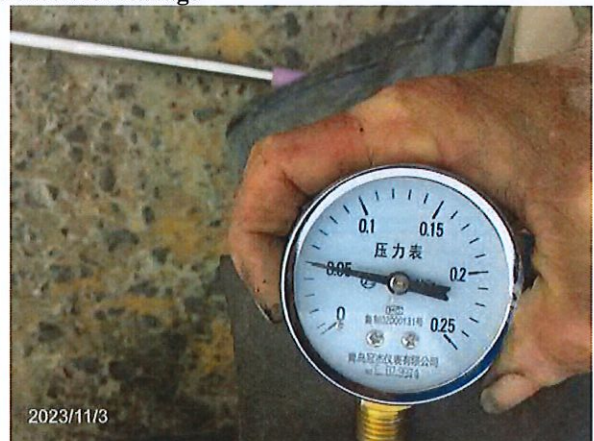
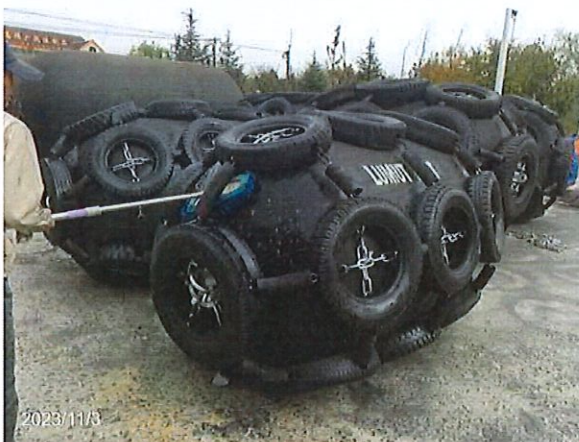
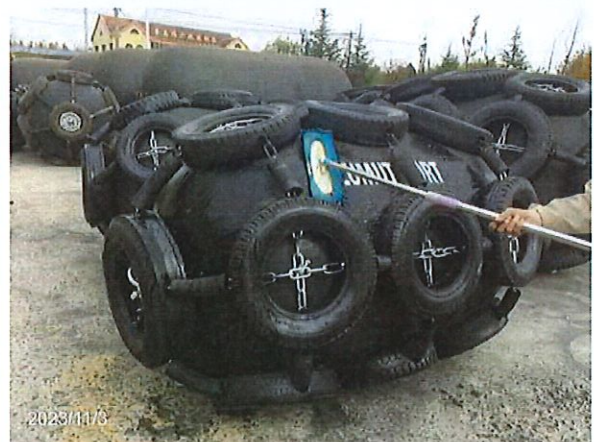
Pressure testing to check for leakage

According to client's requirement, the above mentioned 5 pieces of fenders were charged at pressure declared by 50KPa under BV inspector witness, then covered with the soap water on the surface of the fender to check the air leak

if any, as far as visually checked, it's found in normal conditions, after 1 hour, checked the pressure again, no obviously air leak was found visually.

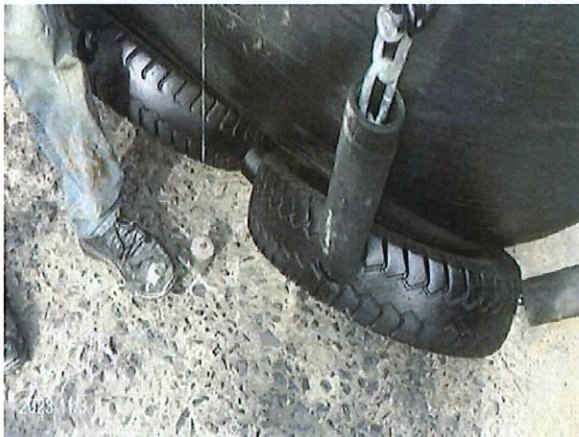
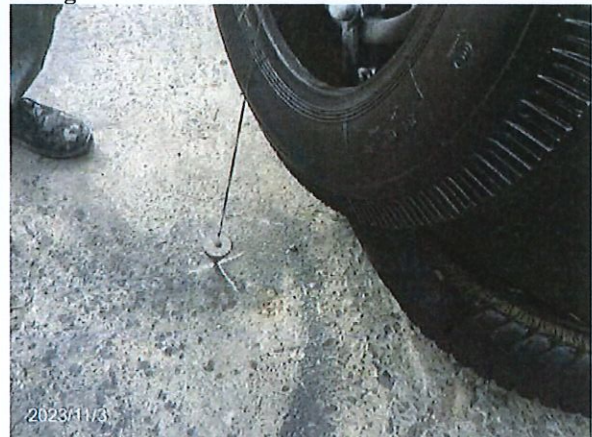
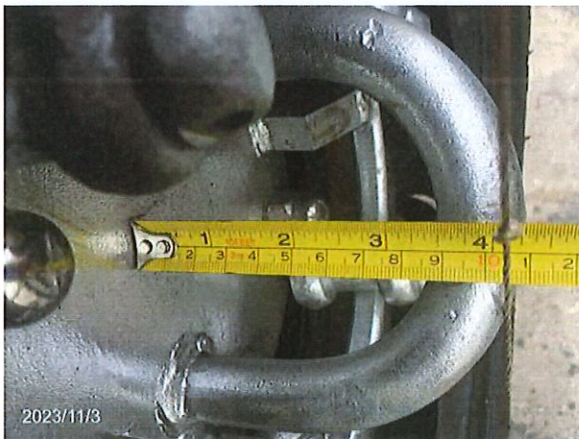
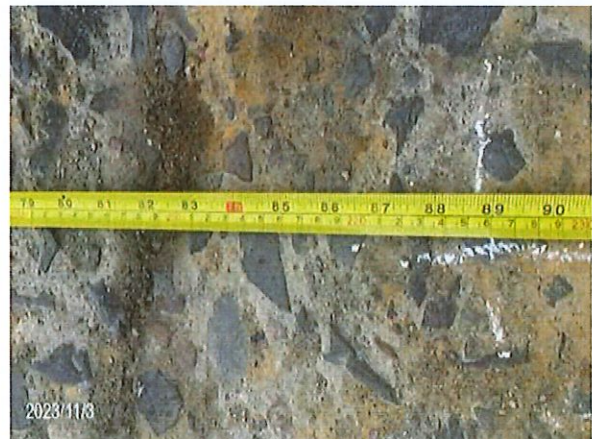
Size checking

According to client's requirement, total 5pcs of fenders were measured sizes, including the overall length and overall diameter, details as below:

- The measurement tools were provided by the factory without the calibration certificate, and the measurement was done approximately as shown in pictures here under. The result was for reference only.
- The measurement was checked at inflated 50kpa pressure.

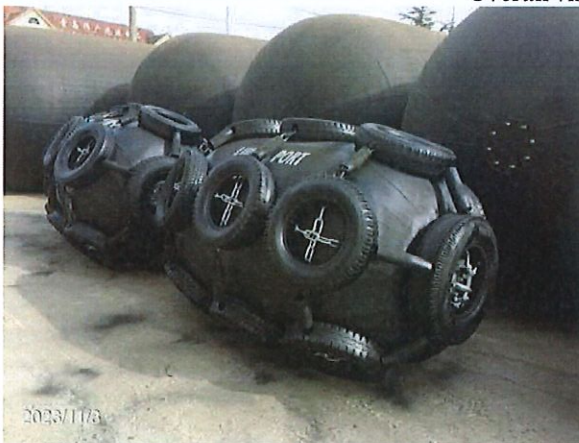
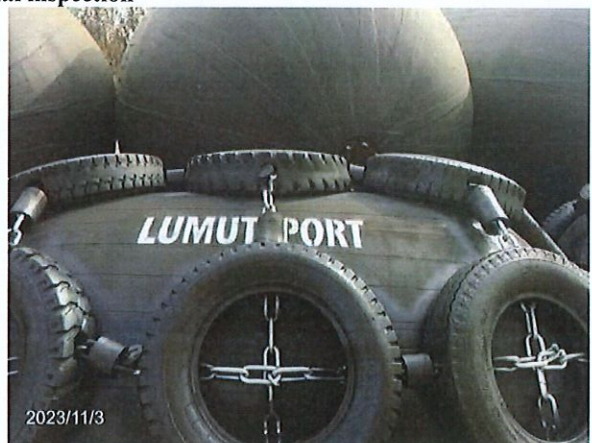
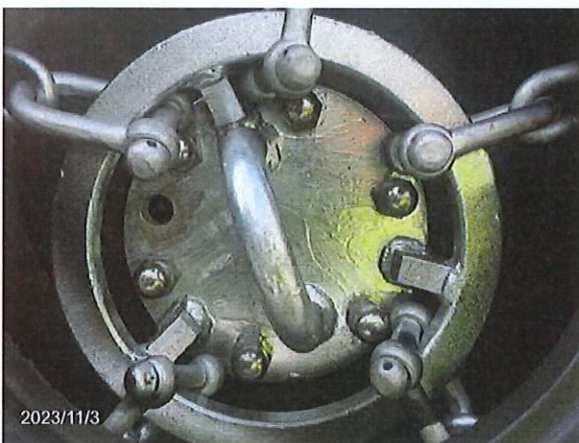
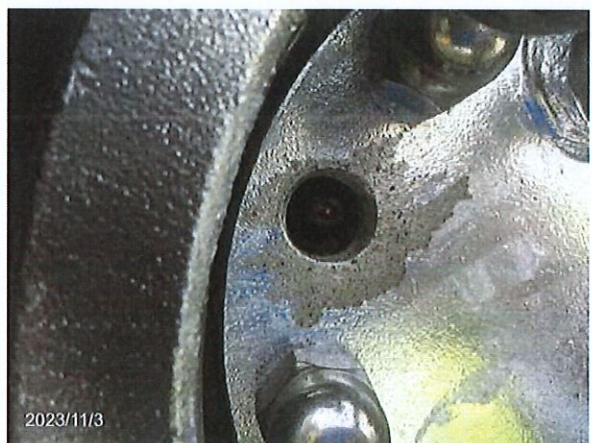
Overall visual inspection

According to client's requirement, BV inspector found the above mentioned 5 pieces of fenders were in normal condition without obviously damage and scratches.
