BUREAU
VERITAS

BV Ref.: GTS 2024 108005

Inspection Report

Applicant : [REDACTED]
Declared Manufacturer : Qingdao Henger Shipping Supplies Co., Ltd.
Declared End User : [REDACTED]
Declared Commodity & Quantity : Pneumatic rubber fender
DIAMETER:4.5M, LENGTH:6.5M: 5PCS
Inspection Date : January 19, 2024
Inspection Location : Jimo, Qingdao City, Shandong Province, China
Scope of Inspection : 1. Packing and Marking
2. Size checking (the overall L & D)
3. Overall visual inspection
4. Air tightness test to check for leakage

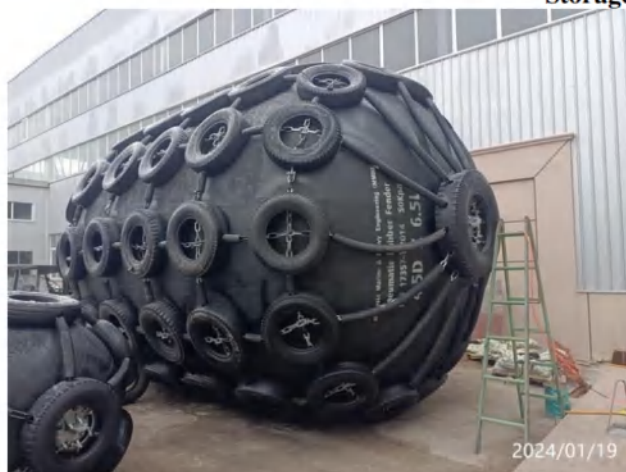
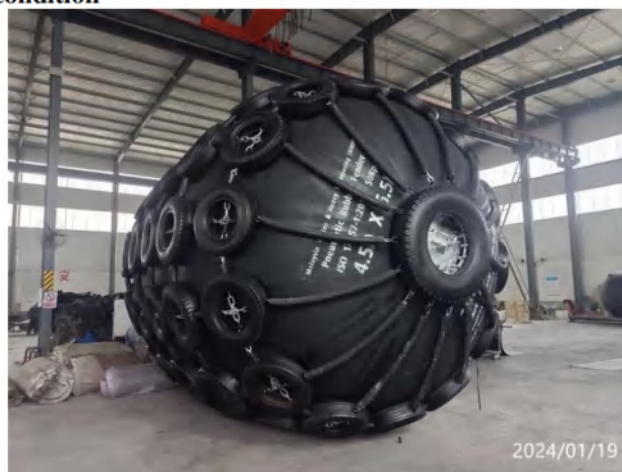
**Photo Report
Storage condition**

At the time of our attendance at the factory, we found the fenders were stored in the manufacturer's open yard, in normal condition.

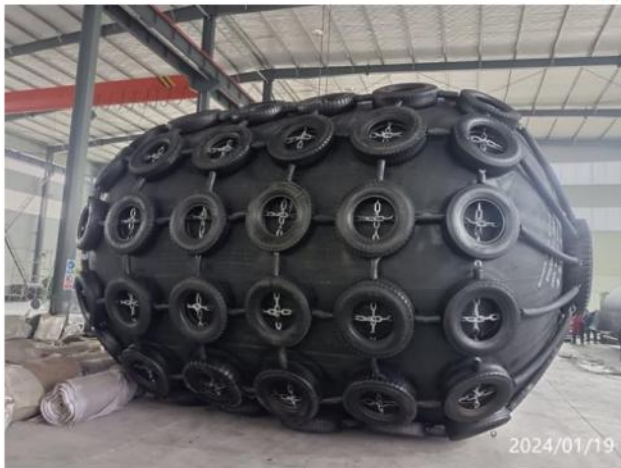
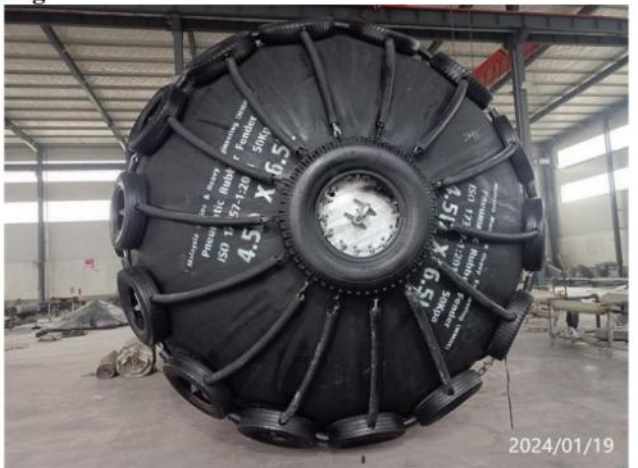
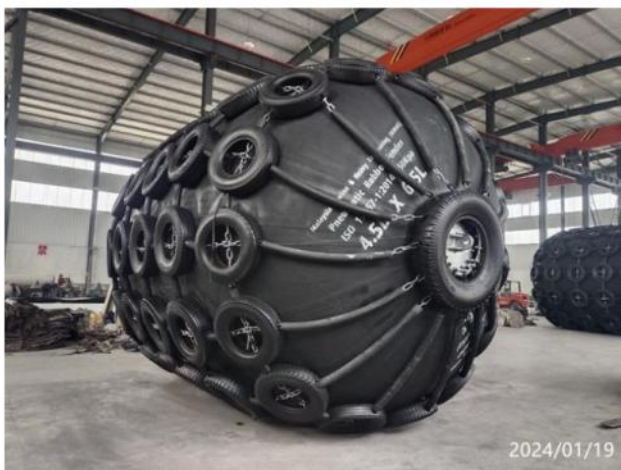
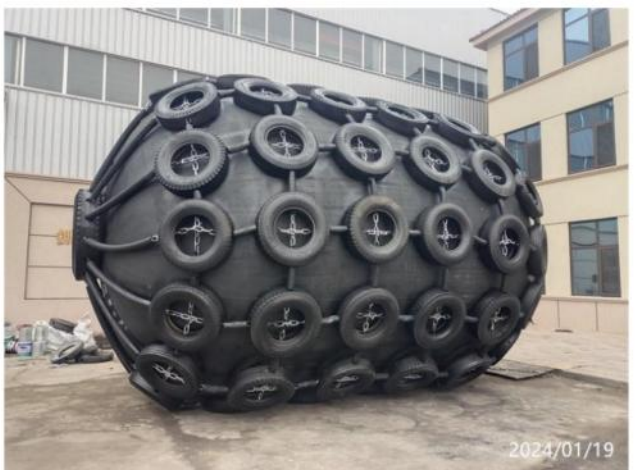
Packing

The Fenders were in nude packing, with the chains and used tires around the fenders' body.

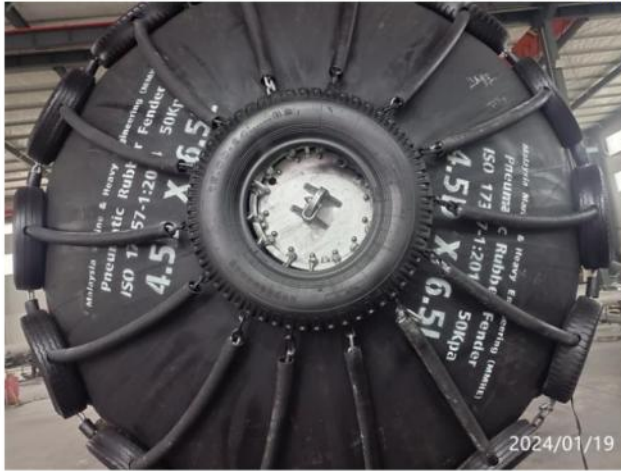
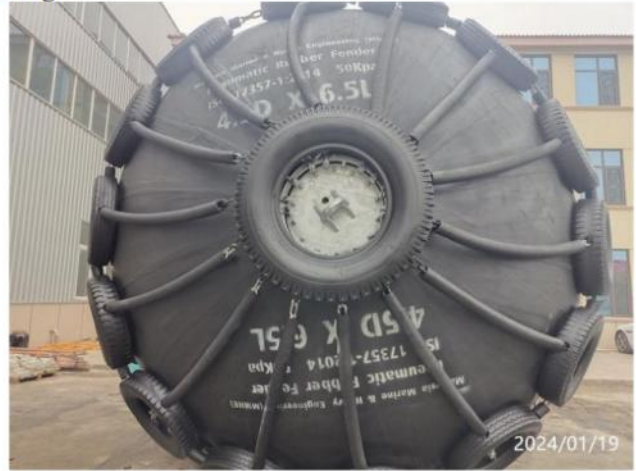
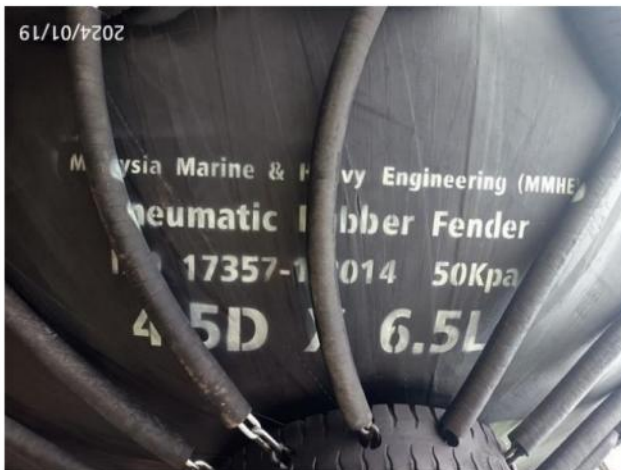
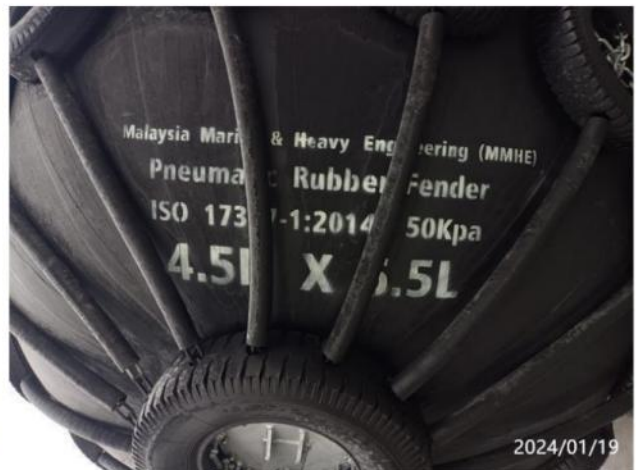
Marking

The marking was printed on two ends of fenders, details as below:

Malaysia Marine & Heavy Engineering (MMHE)
Pneumatic Rubber Fender
ISO 17357-1:2014 50Kpa
4.5D X 6.5L

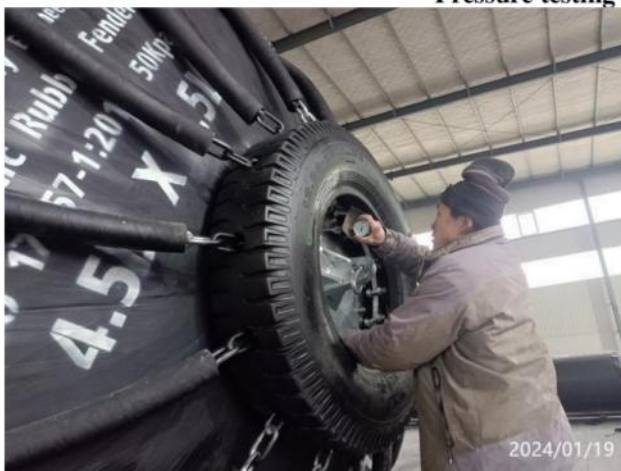
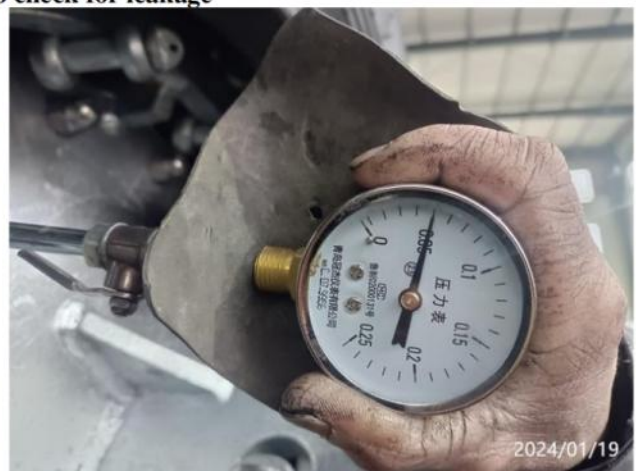
Pressure testing to check for leakage

According to client's requirement, the above mentioned 5 pieces of fenders were charged at pressure declared by 50KPa under BV inspector witness, as far as visually checked, it's found in normal conditions, after 1 hour, checked the pressure again, found the pressure was 50Kpa, no obviously air leak was found visually.

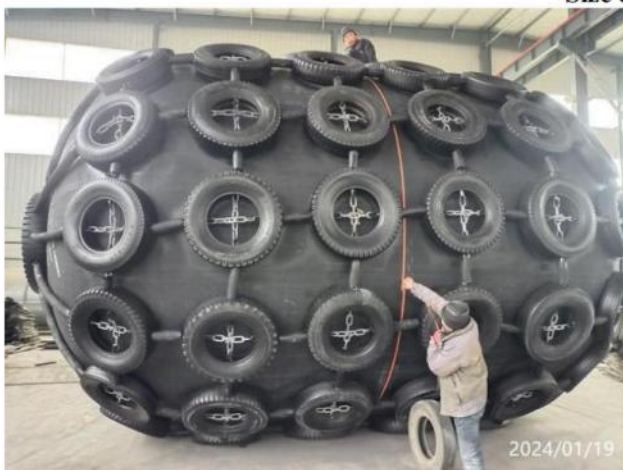
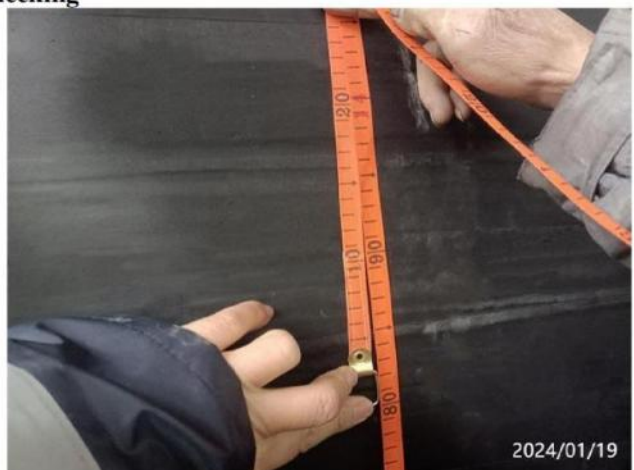
Size checking

Sample No.	Diameter(M)	Length(M)
1	4.39	6.67
2	4.41	6.62

The measurement tools were provided by the factory without the calibration certificate, and the measurement was done approximately as shown in pictures hereunder. The result was for reference only.

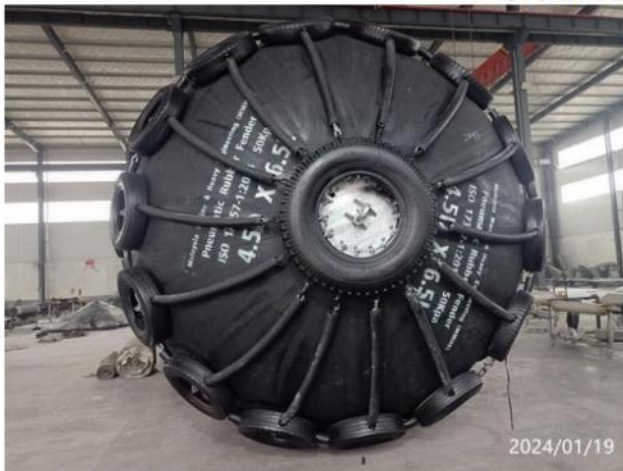
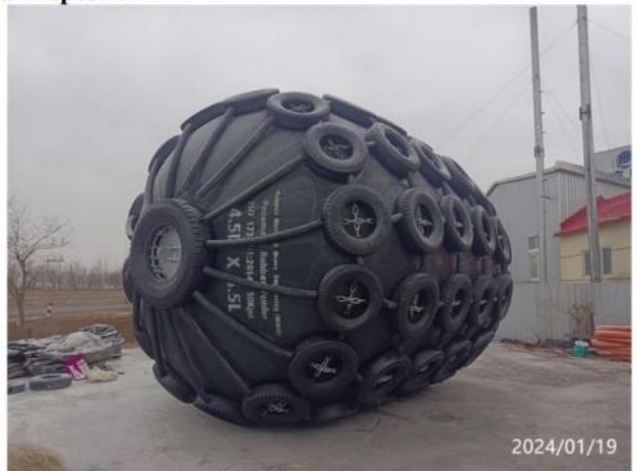
Overall visual inspection

According to client's requirement, BV inspector found the above mentioned 5 pieces of fenders were in normal condition without obviously damage and scratches.

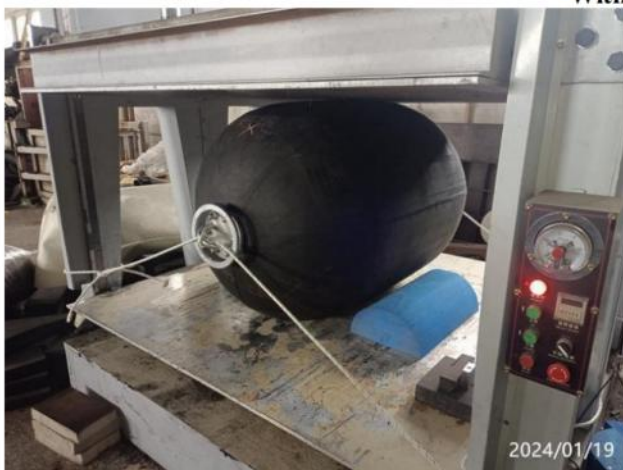
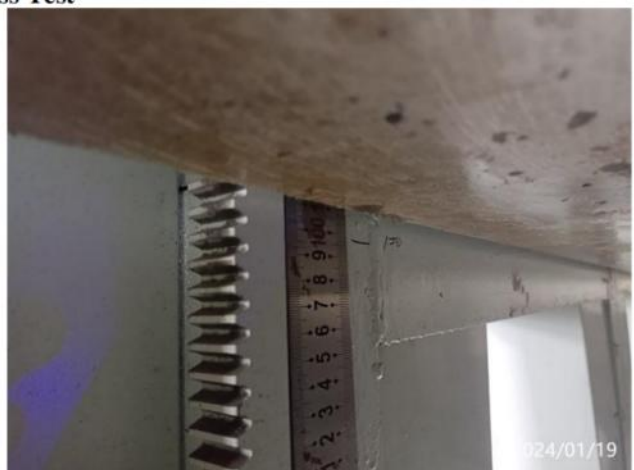
Witness Test

As per client's request, based on ISO17357-1:2014, term 8.5.3, 1 piece of D:1.0m X L:1.5m was provided by the supplier to do the testing witness for compression recovery test. The detail as follow.

Deformation rate	Counter Force (KN)	Energy Absorption (KN-M)	Compression Recovery(within 5 minutes)
60%	187	71	99%

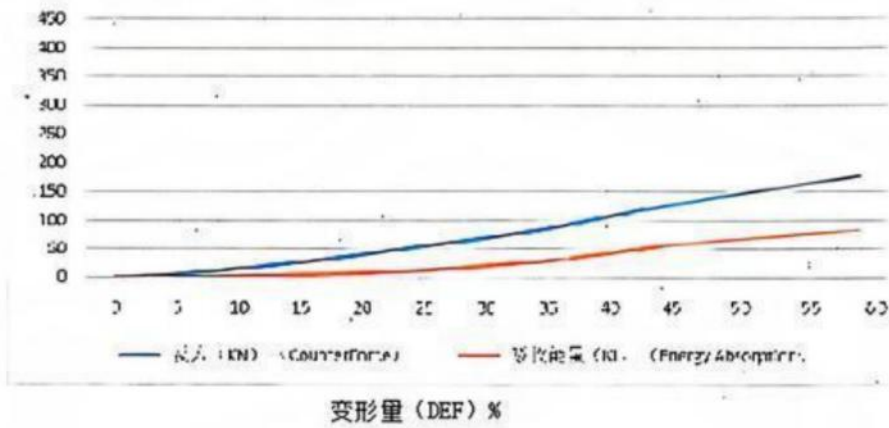
JYX-1000*1500 性能测试 (Performance Curve)

变形量 % (DEF)	反力 (KN) (CounterForce)	吸收能量 (KJ) (Energy Absorption)
0	0	0
5	5.243	0.267393
10	15.435	1.5435
15	26.411	4.014472
20	39.543	8.027229
25	55.713	13.983963
30	69.58	21.08274
35	85.701	30.166752
40	105.644	42.468888
45	128.037	57.87271967
50	139.85	62.49664
55	160.74	68.9837203
60	187.082	71.00376
