## Inspection Report

**Client Name** : QINGDAO HENGER SHIPPING SUPPLIES CO., LTD.

**Declared Commodity & Quantity** : Ship Launching Airbag  
D2.0 X L18M: TOTAL: 16PCS  
D2.0 X L15M: TOTAL: 6PCS  
D2.0 X L6M: TOTAL: 2PCS

**Inspection date** : June 9,2022

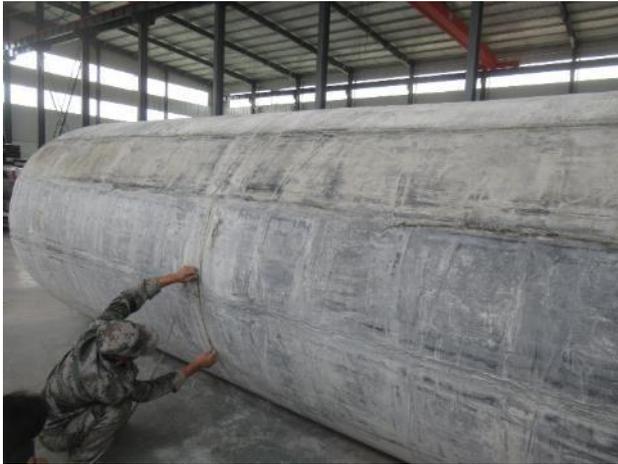
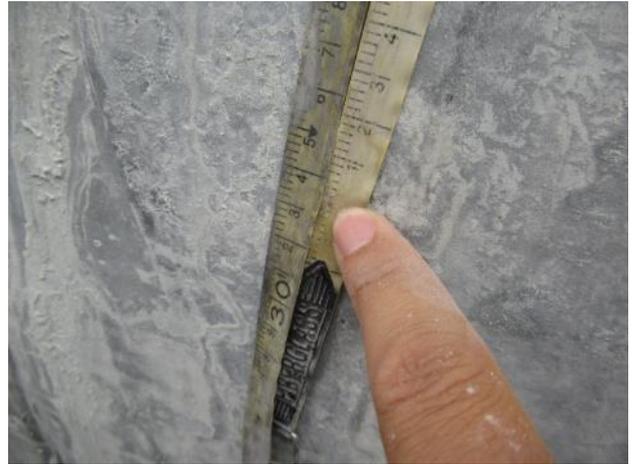
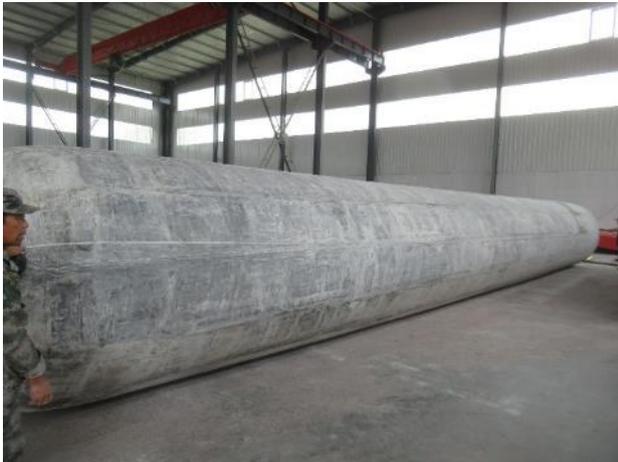
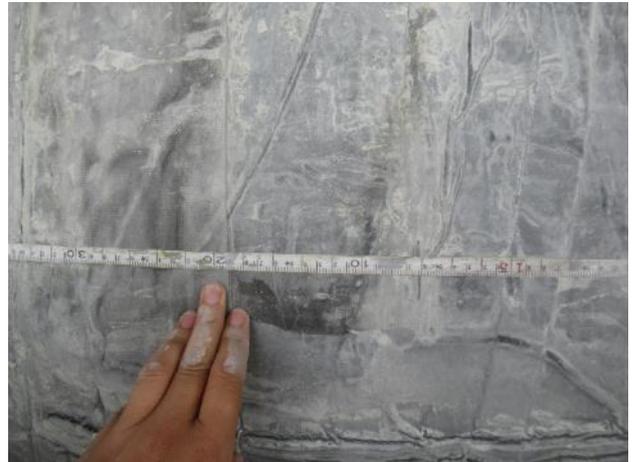
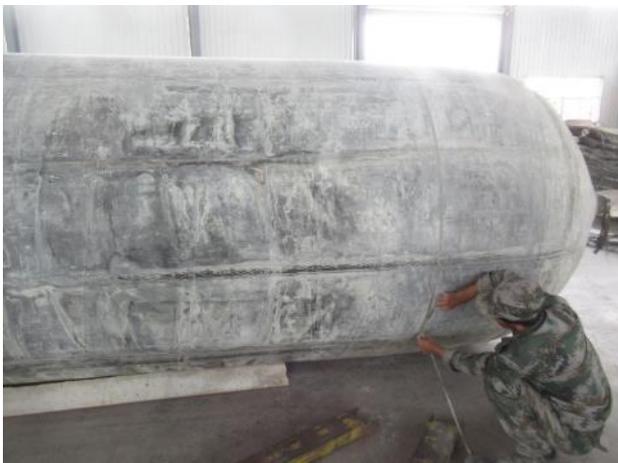
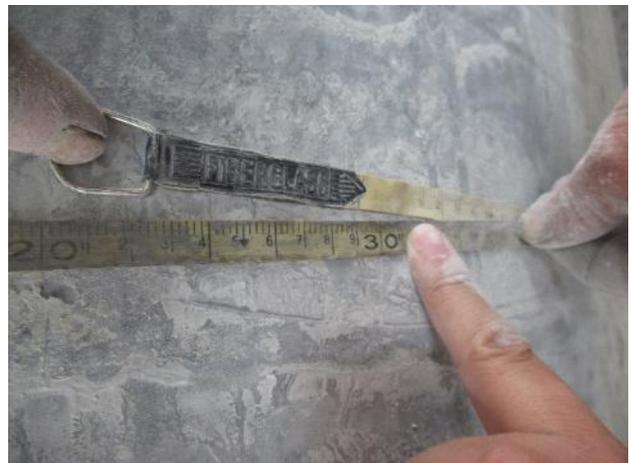
Airtightness testing to check for leakage

According to client's requirement, the above mentioned 3pcs of ship launching airbag were randomly selected, charged at airtightness and pressure declared by 0.08Mpa under BV inspector witness. After 1 hour, checked the pressure again, as far as visually checked, it's found in normal conditions, no air leak was found visually.

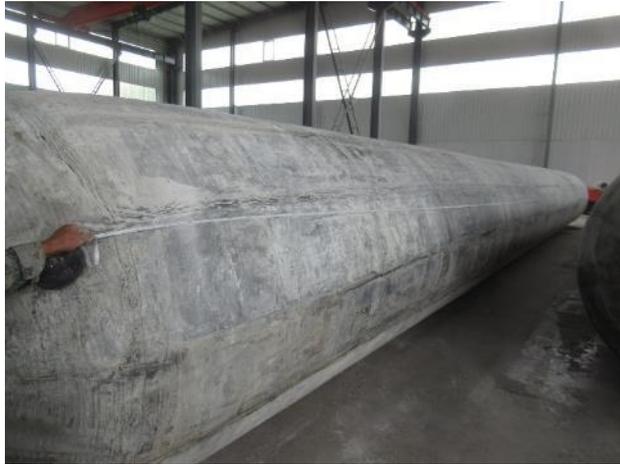
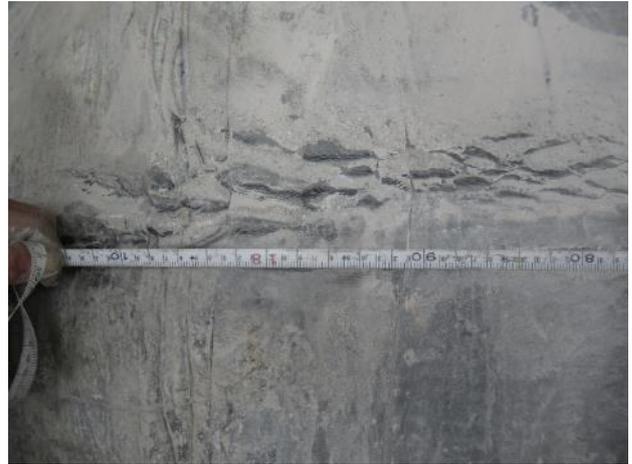
Overall visual inspection

According to client's requirement, the above mentioned 3pcs of ship launching airbags checked by visually, BV inspector found the airbags in normal condition without obviously damages and scratches.
