Inspection Report

- Applicant** : Qingdao Henger Shipping Supplies Co., Ltd.
- Declared Commodity & Quantity** : Pneumatic rubber fender
DIAMETER:2.0M, LENGTH:4.0M: 5PCS
DIAMETER:1.5M, LENGTH:3.0M: 4PCS
DIAMETER:1.0M, LENGTH:3.0M: 2PCS
DIAMETER:1.0M, LENGTH:2.0M: 3PCS
- Inspection Date** : December 26, 2023
- Inspection Location** : Jimo, Qingdao City, Shandong Province, China
- Scope of Inspection** : 1. Packing and Marking
2. Size checking (the overall L & D)
3. Overall visual inspection
4. Air tightness test to check for leakage

BV Ref.: GTS_2023_370416

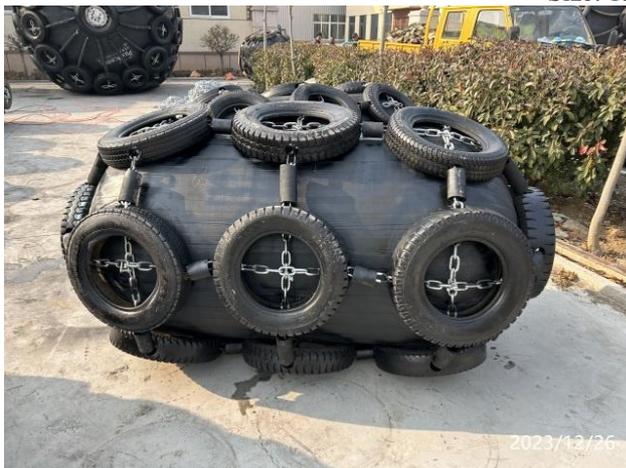
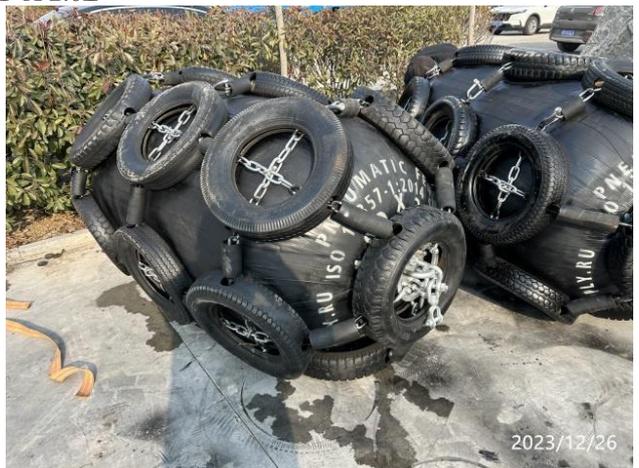
Packing
Size: 1.0D X 2.0L

According to client's requirement, 2pcs per size were randomly selected, total 8pcs of fenders were measured sizes, including the overall length and overall diameter, details as below:

1	1.52	3.07
2	1.52	3.09
Size: 2.0D X 4.0L		
1	1.99	4.05
2	2.00	4.02

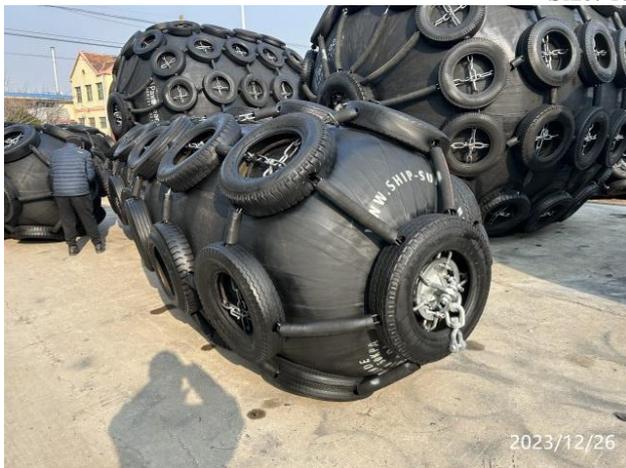
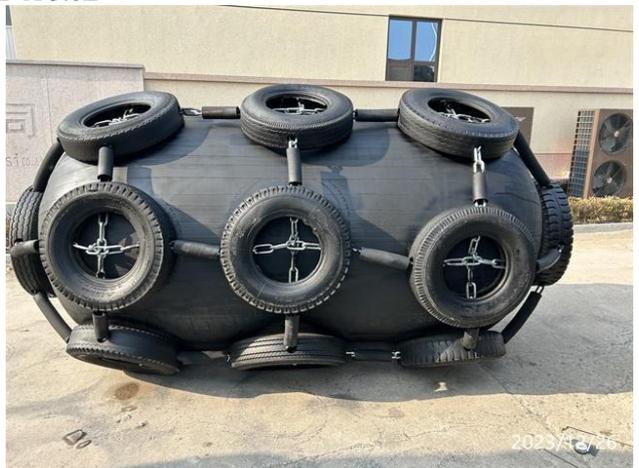
Size: 1.0D X 2.0L		
Sample No.	Diameter(M)	Length(M)
1	1.00	2.01
2	1.01	2.00
Size: 1.0D X 3.0L		
1	1.00	3.05
2	1.00	3.08
Size: 1.5D X 3.0L

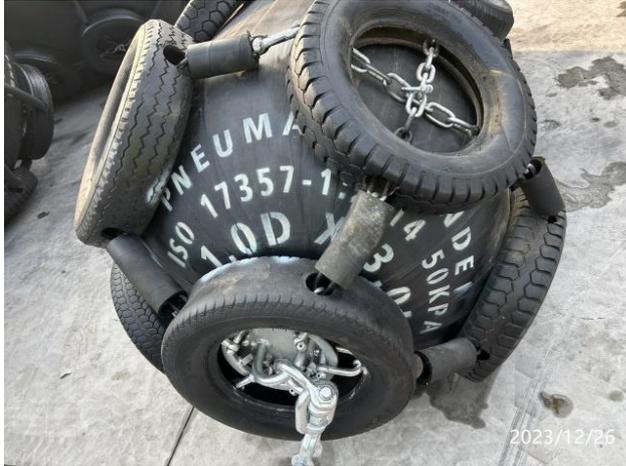
Size: 1.0D X 3.0L

The marking was printed on one end of fenders, details as below:

PNEUMATIC FENDER
ISO 17357-1:2014 50KPA
1.0D X 2.0L (1.0D X 3.0L or 1.5D X 3.0L or 2.0D X 4.0L)
WWW.SHIP-SUPPLY.RU

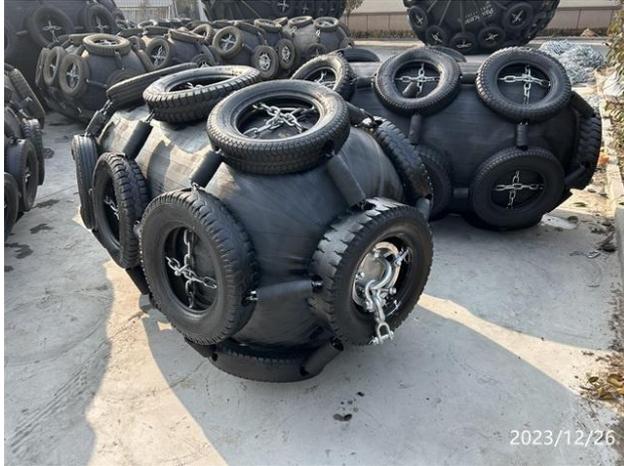
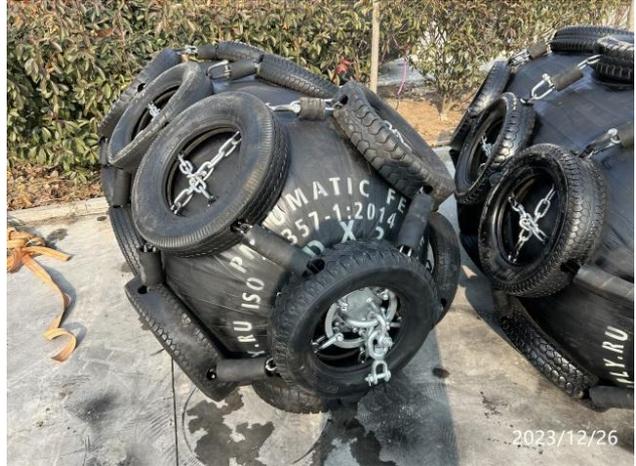
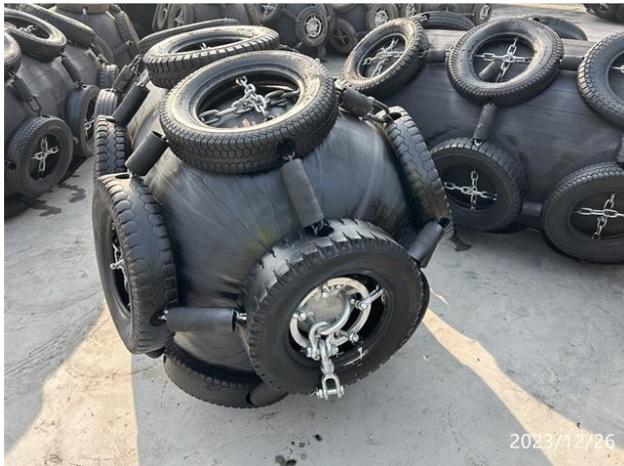
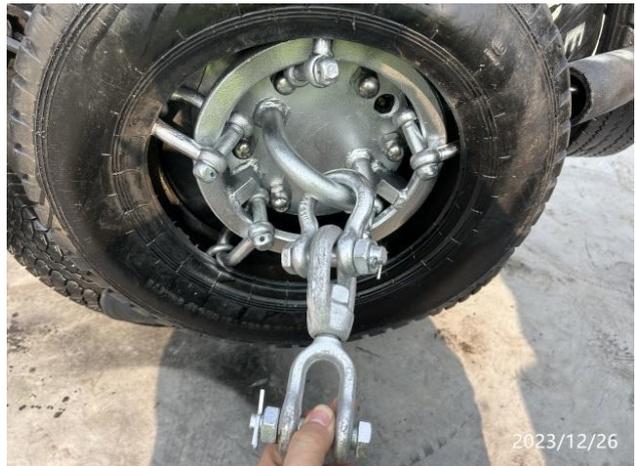
Size: 1.0D X 2.0L

According to client's requirement, BV inspector found the above mentioned 14 pieces of fenders were in normal condition without obviously damage and scratches.
