BV Ref.: GTS_2023_330472

Inspection Report

Applicant : Qingdao Henger Shipping Supplies Co., Ltd.

Declared Commodity & Quantity : Pneumatic rubber fender
DIAMETER:1.2M, LENGTH:2.0M: 5PCS

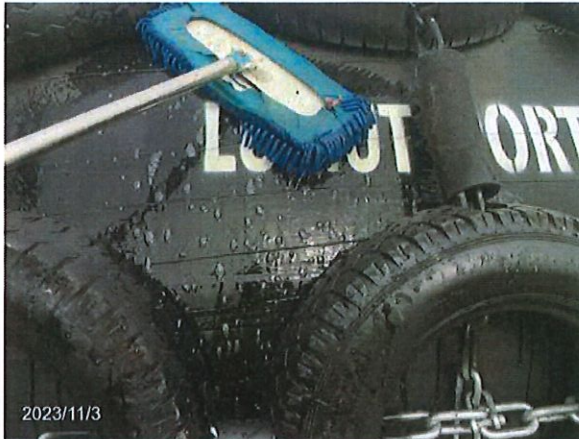
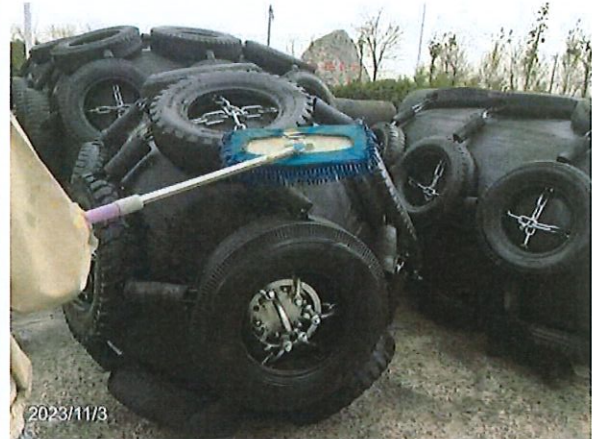
Size checking

According to client's requirement, total 5pcs of fenders were measured sizes, including the overall length and overall diameter, details as below:
