BUREAU
VERITAS

BV Ref.: GTS 2024 108005

Inspection Report

Applicant : [REDACTED]
Declared Manufacturer : Qingdao Henger Shipping Supplies Co., Ltd.
Declared End User : [REDACTED]
Declared Commodity & Quantity : Pneumatic rubber fender
DIAMETER:4.5M, LENGTH:6.5M: 5PCS
Inspection Date : January 19, 2024
Inspection Location : Jimo, Qingdao City, Shandong Province, China
Scope of Inspection : 1. Packing and Marking
2. Size checking (the overall L & D)
3. Overall visual inspection
4. Air tightness test to check for leakage

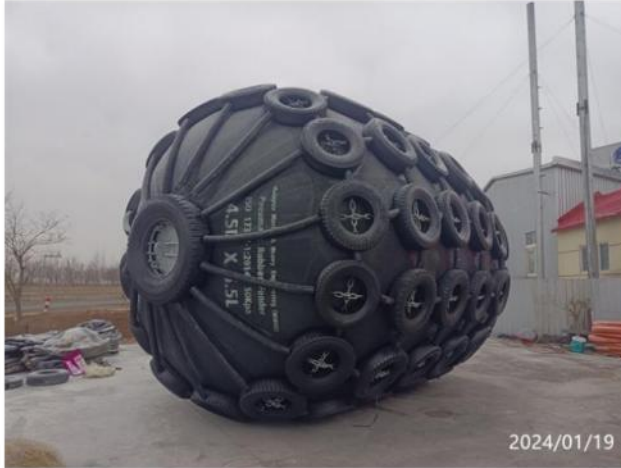
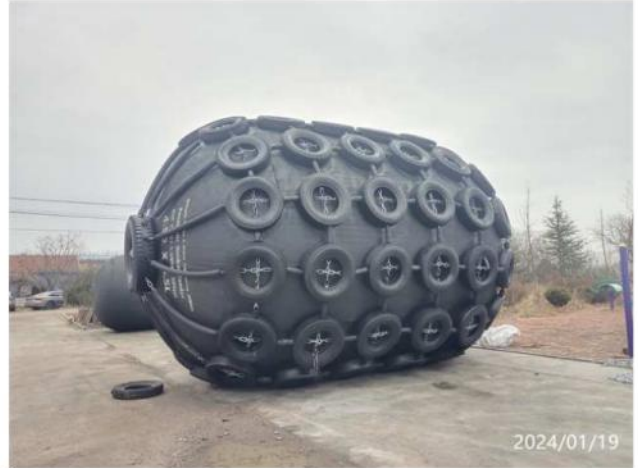
At the time of our attendance at the factory, we found the fenders were stored in the manufacturer's open yard, in normal condition.

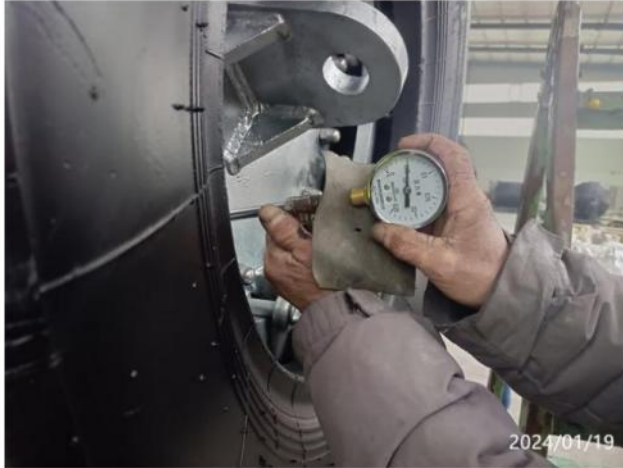
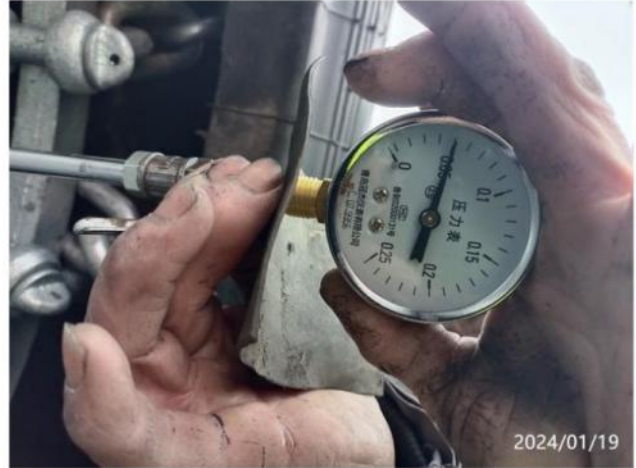
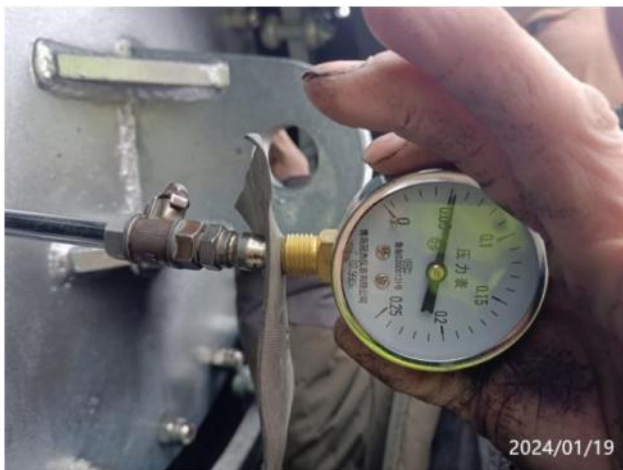
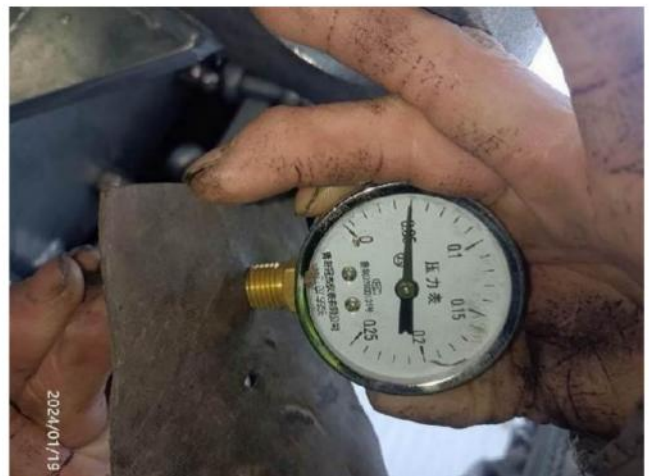
According to client's requirement, the above mentioned 5 pieces of fenders were charged at pressure declared by 50KPa under BV inspector witness, as far as visually checked, it's found in normal conditions, after 1 hour, checked the pressure again, found the pressure was 50Kpa, no obviously air leak was found visually.

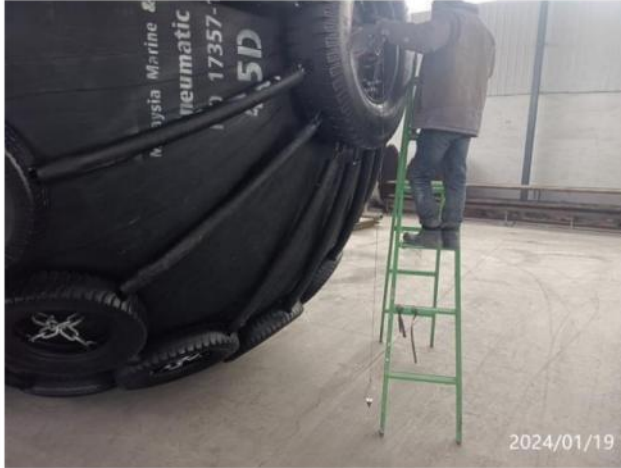
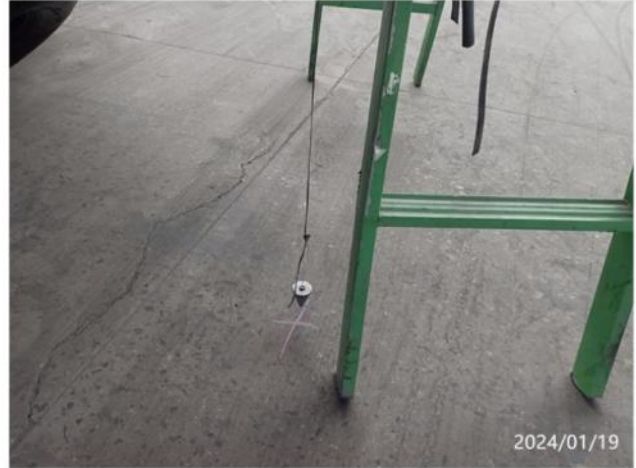
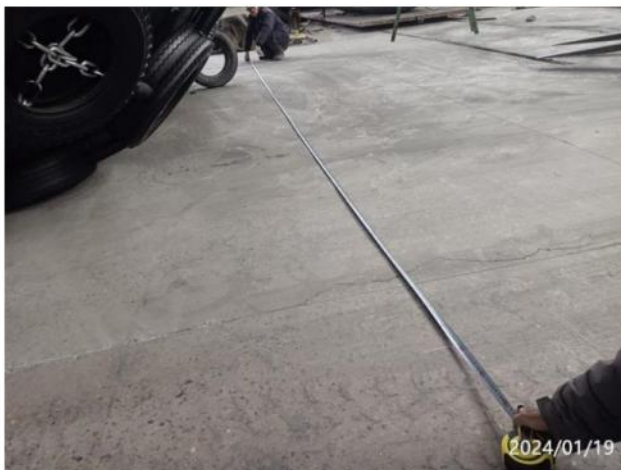
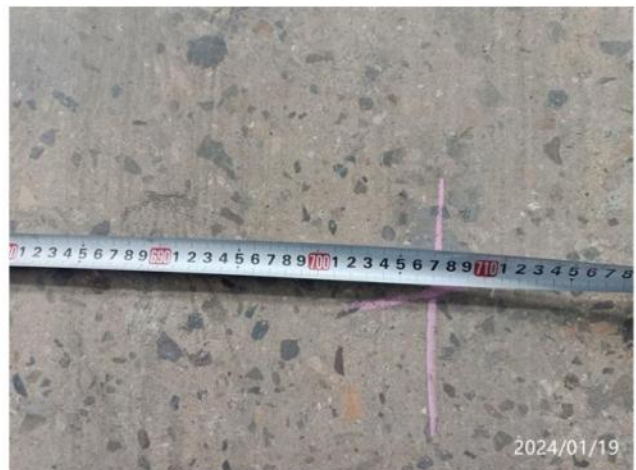
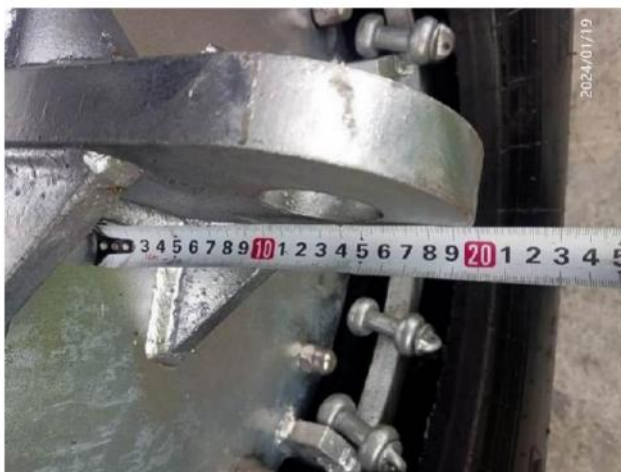
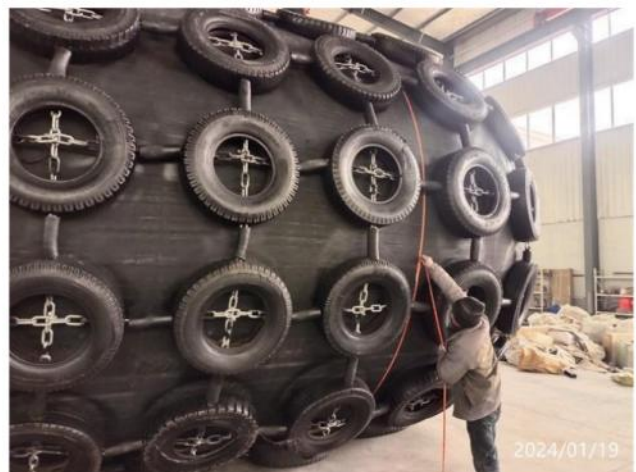
Size checking

Sample No.	Diameter(M)	Length(M)
1	4.39	6.67
2	4.41	6.62

The measurement tools were provided by the factory without the calibration certificate, and the measurement was done approximately as shown in pictures hereunder. The result was for reference only.

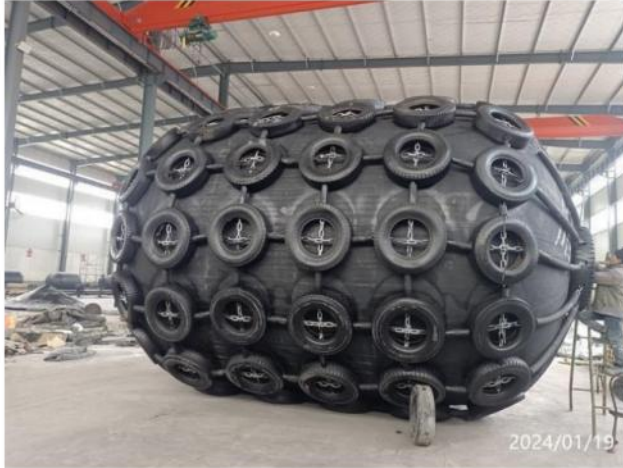
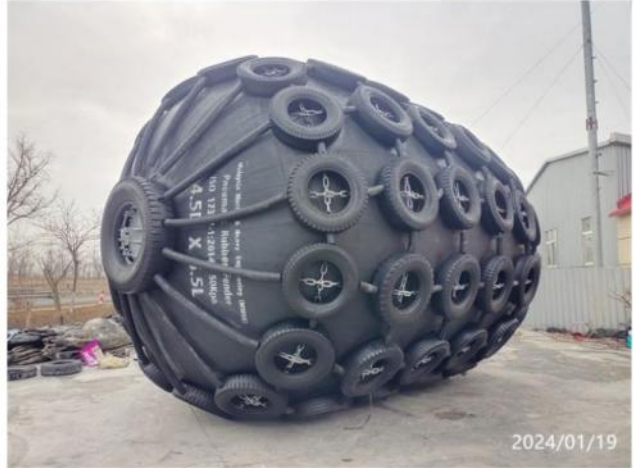
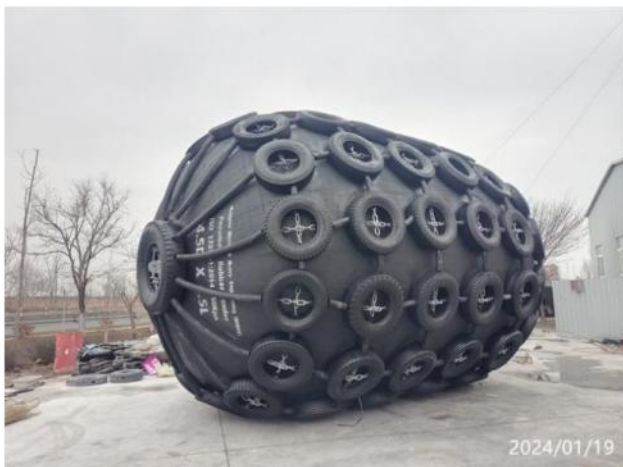
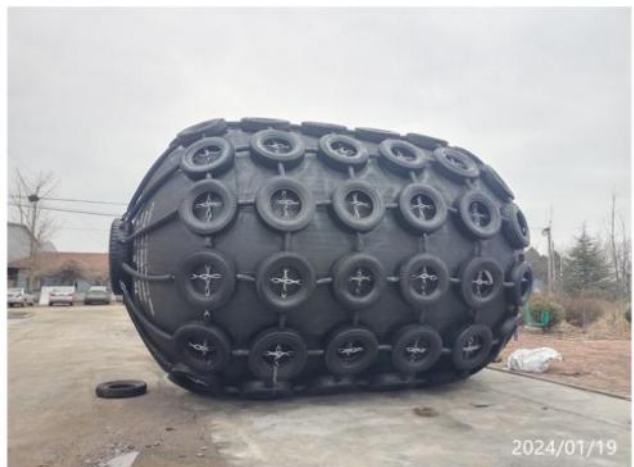
Overall visual inspection

According to client's requirement, BV inspector found the above mentioned 5 pieces of fenders were in normal condition without obviously damage and scratches.

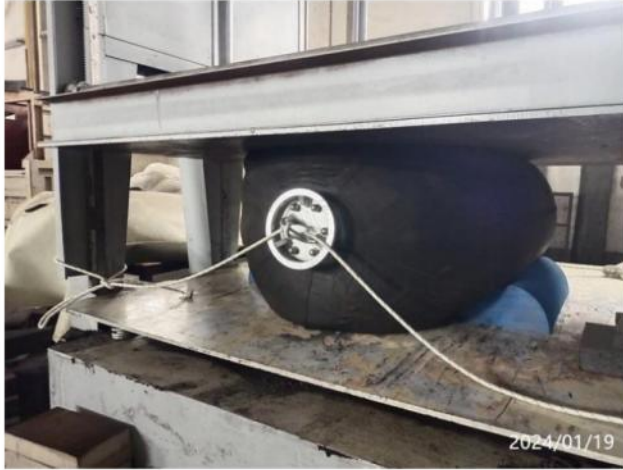
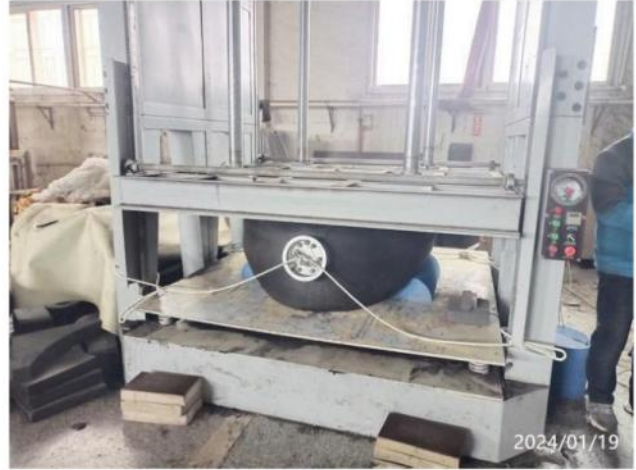
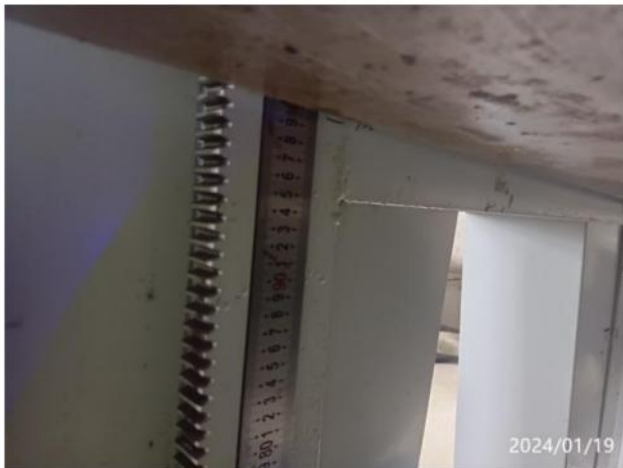
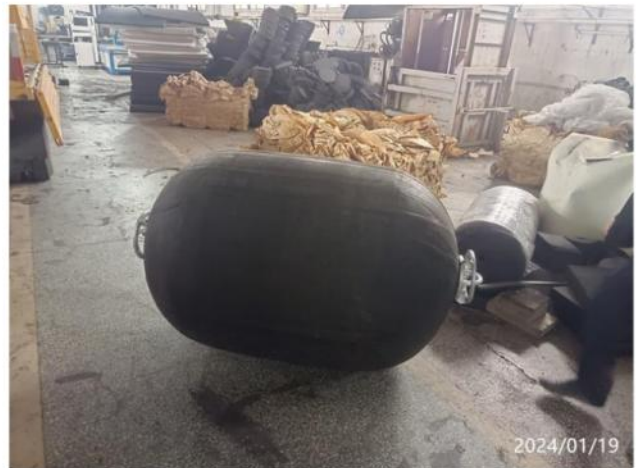
Witness Test

As per client's request, based on ISO17357-1:2014, term 8.5.3, 1 piece of D:1.0m X L:1.5m was provided by the supplier to do the testing witness for compression recovery test. The detail as follow.

Deformation rate	Counter Force (KN)	Energy Absorption (KN-M)	Compression Recovery(within 5 minutes)
60%	187	71	99%
